REPORT
ON
THE WALL FABRIC
OF
'THE MAIN GUARD'
13, JOHN MACKINTOSH SQUARE,
GIBRALTAR.
HEADQUARTERS OF THE GIBRALTAR HERITAGE TRUST

Cádiz, 8th August 2007.

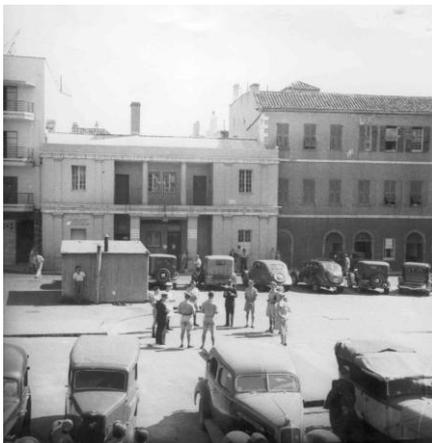
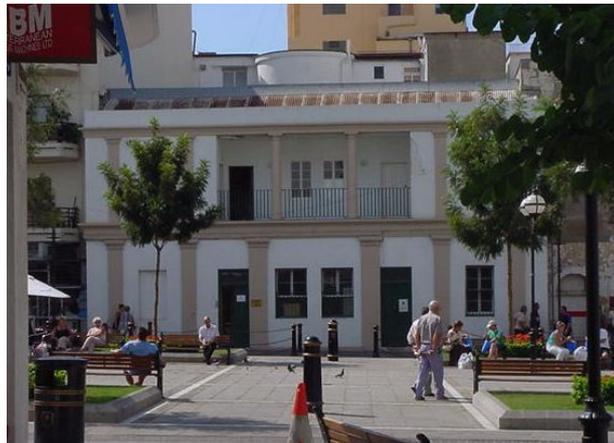
The Building ultimately takes on its present look with the enclosed veranda on the ground floor. Maintenance generally has been poor with unsympathetic extensions and bad repairs and the consequent loss of crisp detail. Blocked rain water pipes and a build up of water proof plastics paint layers is causing damp problems. The upper floor was refurbished when the Gibraltar Heritage Trust moved in.

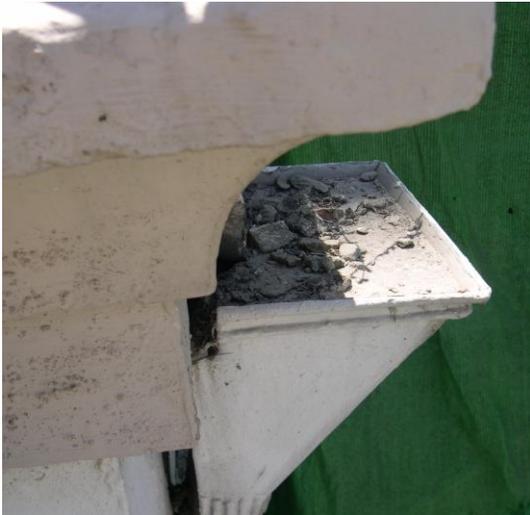
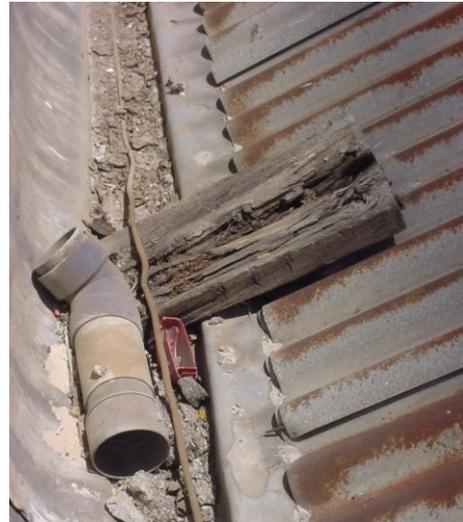
The rain water gutter and hopper heads which were found to be full of accumulations of rubbish and rubble See Appendix 5, explains the damp condition of the interior walls of the Gibraltar Heritage Trusts offices a makes a point of the need to regularly maintain the building after this refurbishment.

During the survey the rain water gutter and hopper head were found to be full of decades of accumulations of rubbish and rubble.

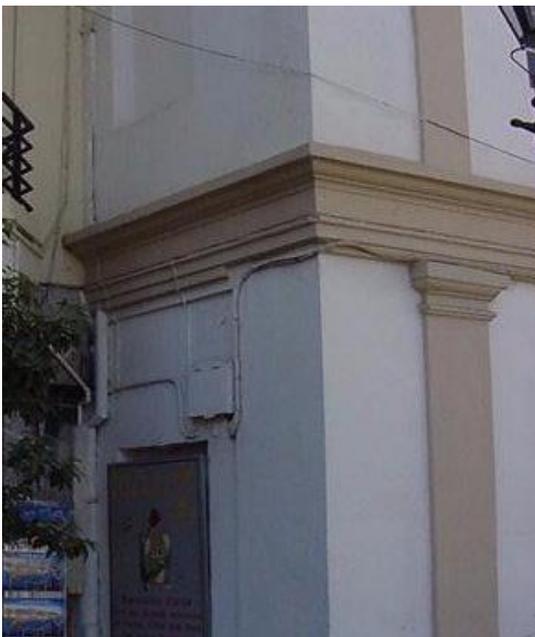
Public utility cables particularly telephone and public lighting are piled on the façade adding to the loss of crispness of detail.
