The Main Guard
John Mackintosh Square,
Gibraltar.

A Report on the Proposed Repairs, Additions and Alterations
for
The Gibraltar Heritage Trust
prepared by
J.S. Langdon B.Arch.
dated
January 2006

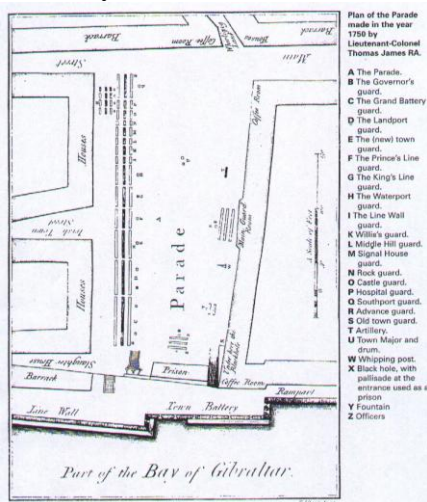
1.2. The 1750 plan.

In a plan of the parade made in 1750 by Thomas James (published in 1770) it is clearly visible, labelled "Main Guard Room," with soldiers mustered outside it.’

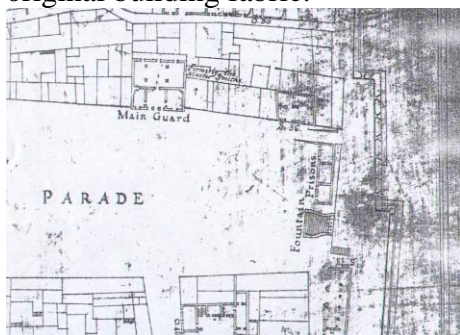
1.3. The 1753 plan.

It is depicted in the 1753 plan of the Town as "The Main Guard". The plan of the building does not show any staircases, confirming Dr Robert Poole's single storey description, however, it does show a loggia with the two central columns, two side windows and a projection of the building line beyond the adjoining buildings very much like the existing. It is therefore probable that the ground floor façade contains original building fabric.

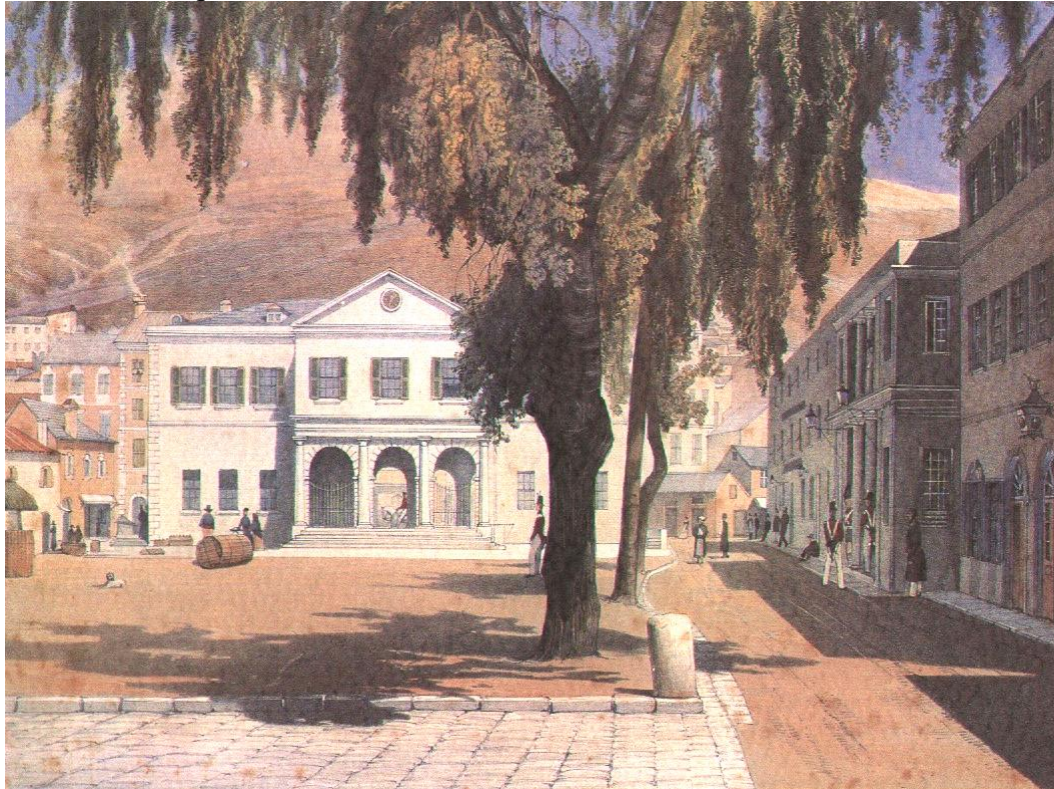
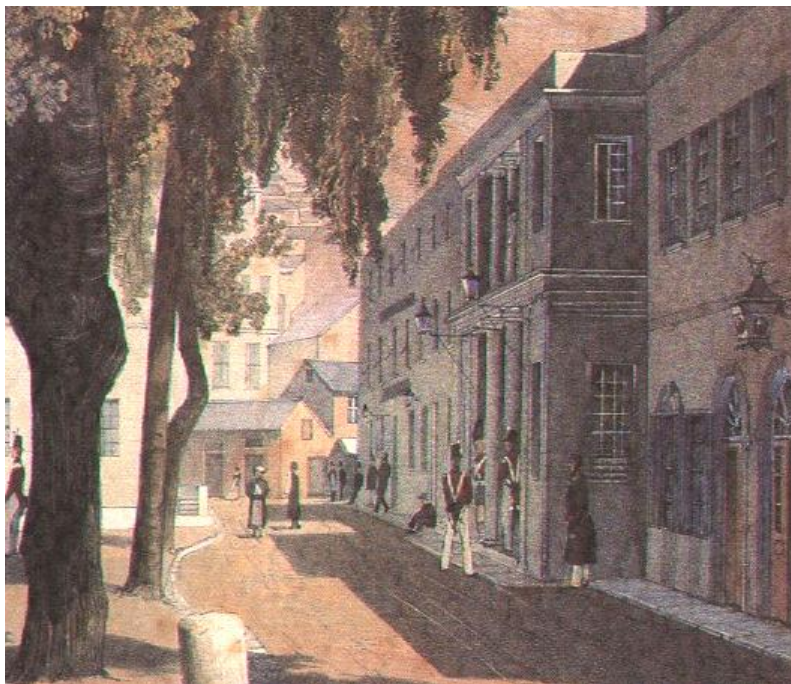
Detail of the Main Guard

It was almost certainly severely damaged by the bombardment during the Great Siege, and the second storey was probably added when it was rebuilt. The two-

storied building, with soldiers on guard, is shown in the Carter print of the Commercial Square (1830).

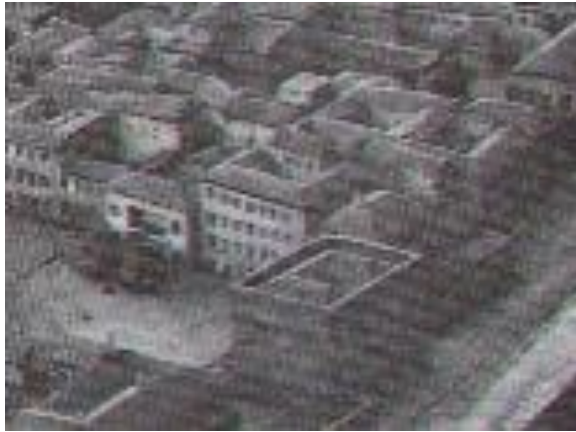
1.5. The 1865 Model.

The building façade is in its present 2 storey form.
