HM Government  
of Gibraltar

**Report on the investigation of fatal accident during mooring  
operations on board the motor tanker**

*“NISYROS”*

20 May 2025

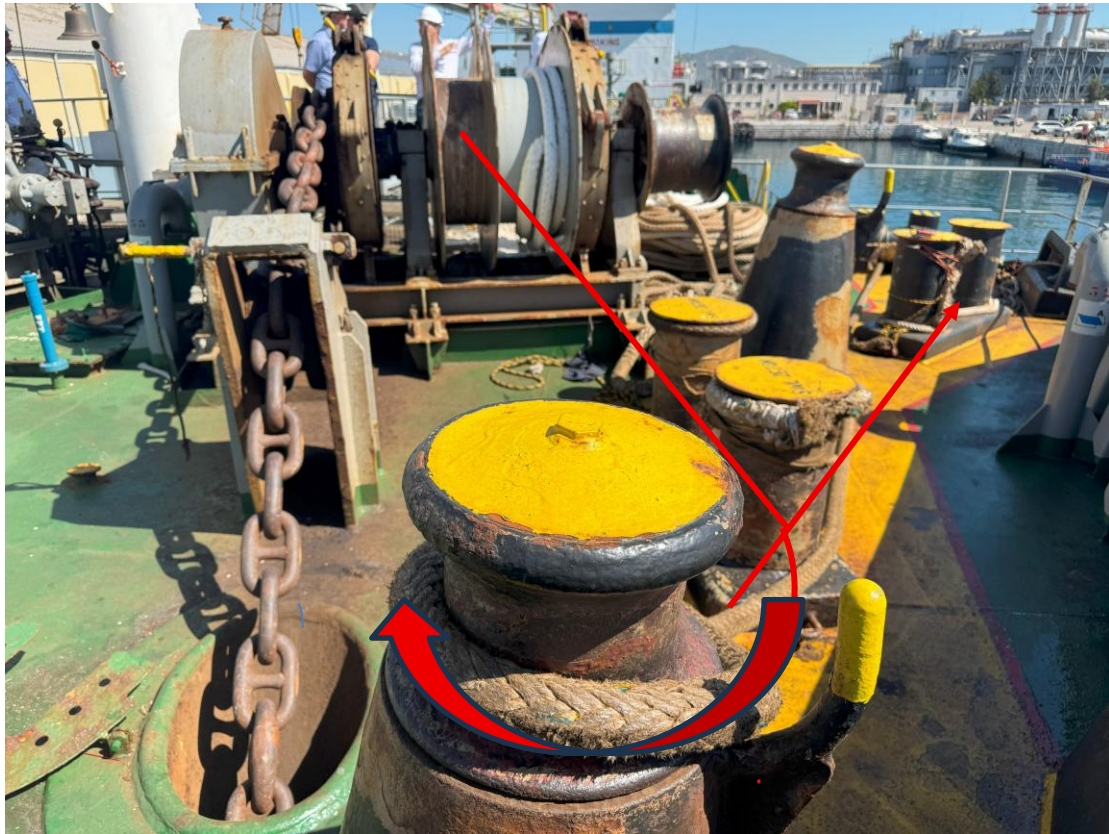
**Fig. 4 – FWD spring mooring line arrangement. Red lines depict direction line took from drum leading forward, around pedestal roller and then leading aft**

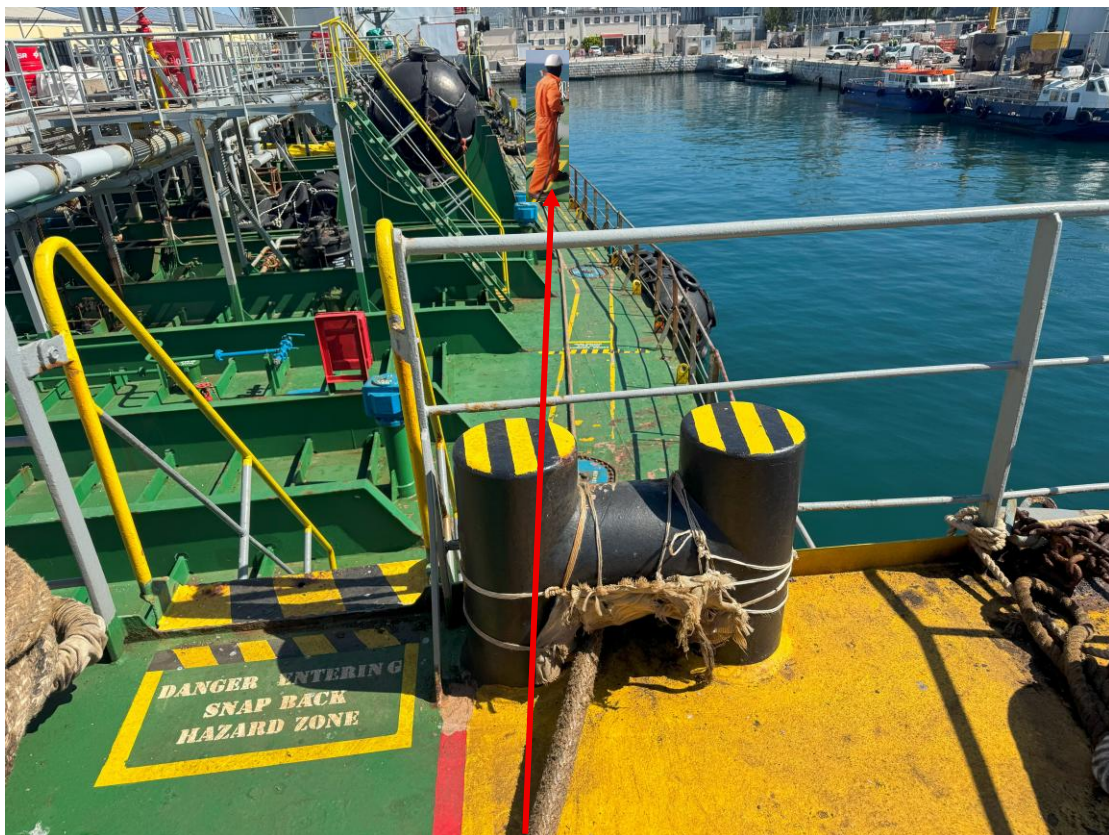
**Fig. 5 – FWD spring mooring line through aft leading fairlead down to main deck and approximate position of seaman on main deck**

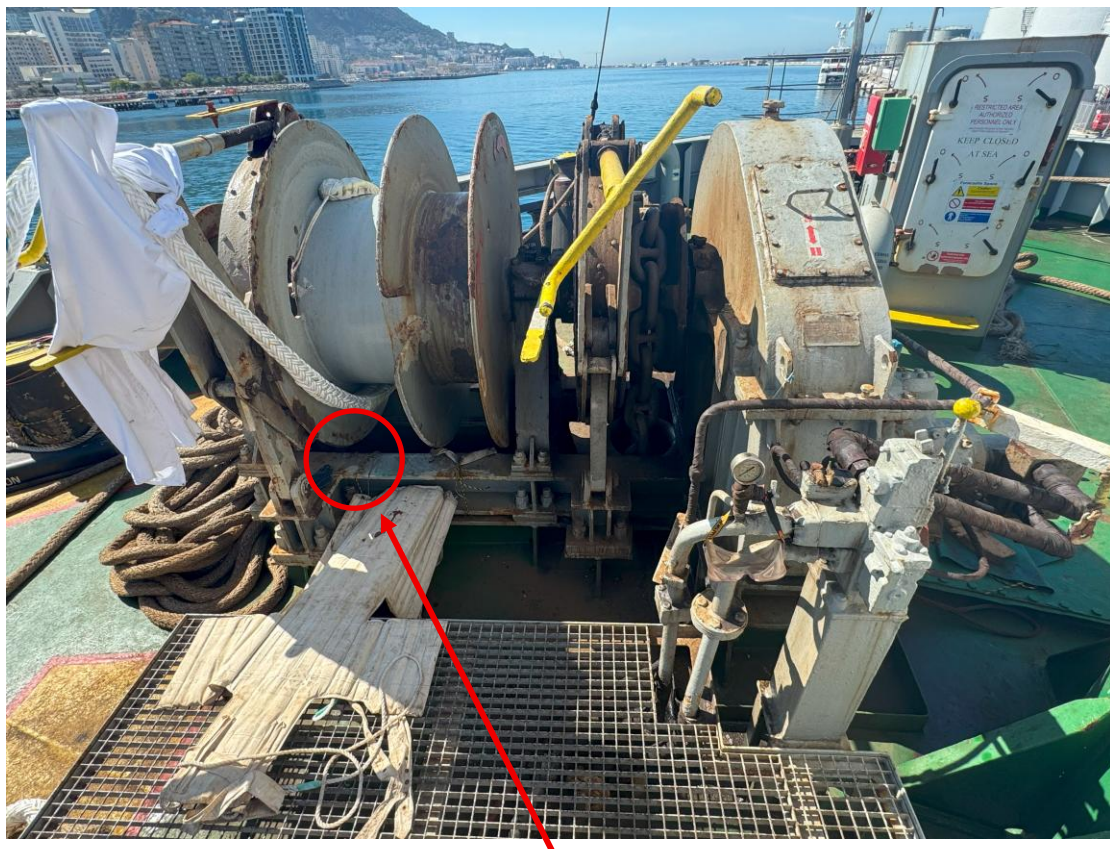
Upon arrival at the forecastle, he discovered that the Pumpman - crew member on site was trapped beneath the winch drum and immediately informed the bridge via VHF and stopped the winch's hydraulic motor. The Chief Officer and another crew member arrived at the scene shortly thereafter.

**Fig 6 – Image demonstrating location of crew member**

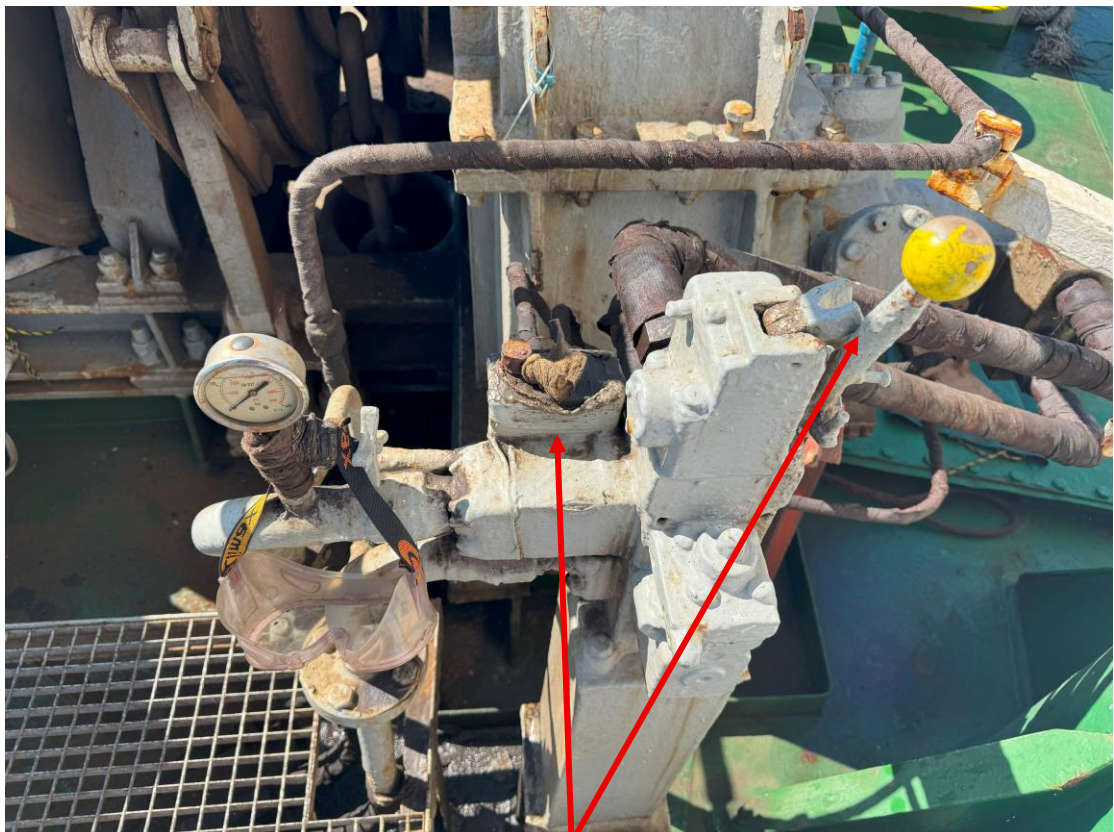
**Fig 12 – View of valve in slow speed position and safety catch in position maintaining winch active.**

However, it was observed that—contrary to proper procedures—the winch can be kept active by securing the lever with its safety catch. This action allows the drum to continue rotating without continuous manual activation of the lever (Figure 12).

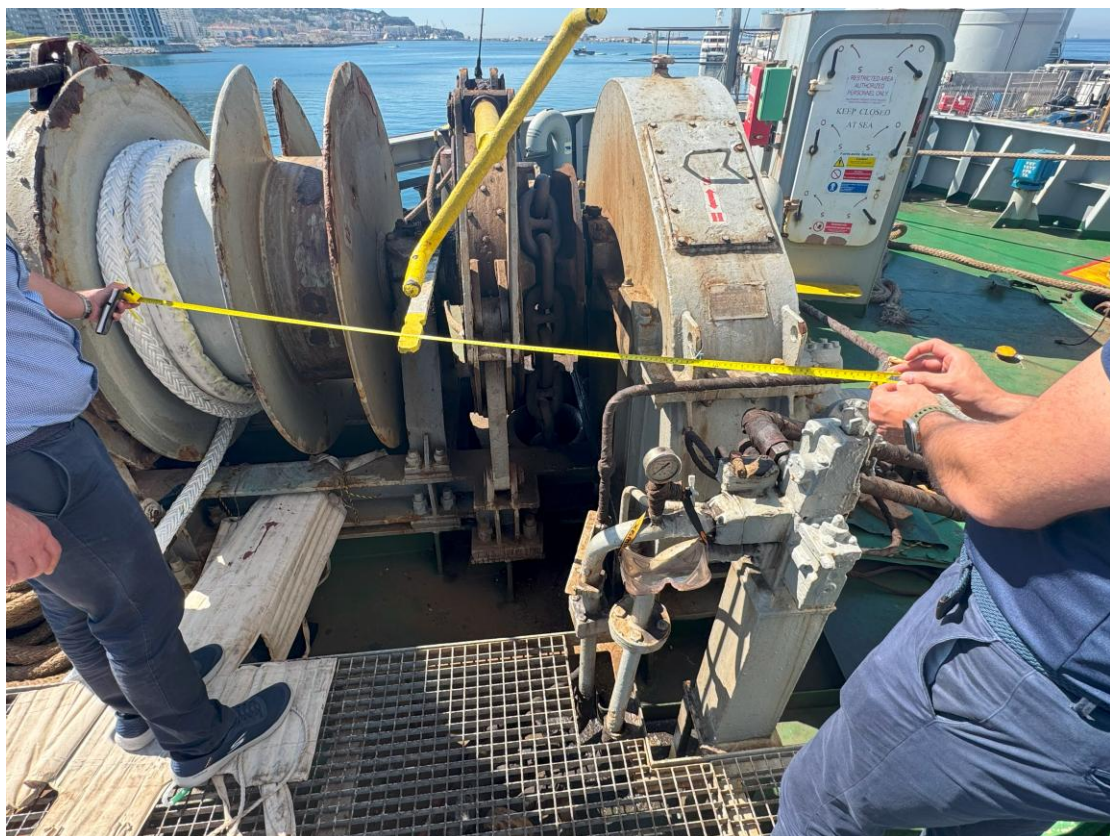
Inspection revealed that the spatial distance between the winch operational lever and the drum was 1.90 m. Taking this into consideration, if the winch had been operated in accordance with its design function, it would have been difficult for a person located by the drum, or at the position where the deceased was found, to be within simultaneous reach of the operational lever (Figures 13 and 14).

***Fig- 13 View of the distance between the winch operating lever and location of where Pumpman was found.***

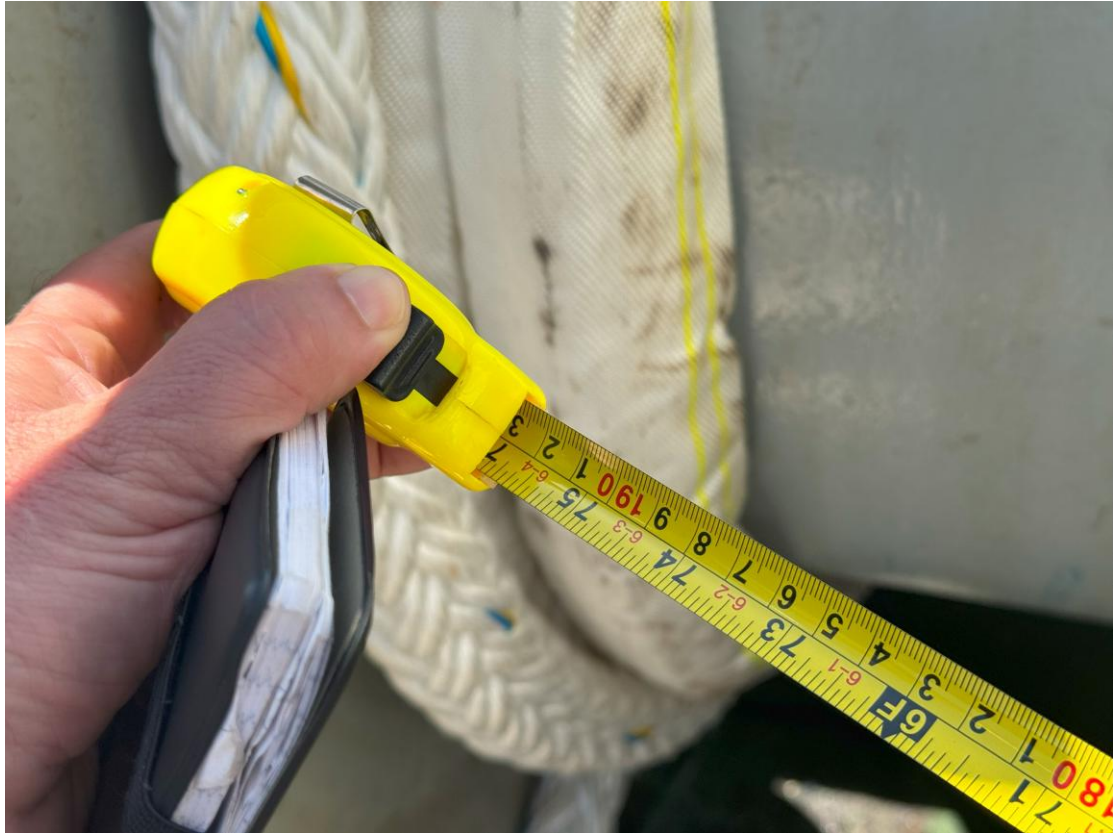
***Fig-14 Image to demonstrate distance to be approximately 1.90m***

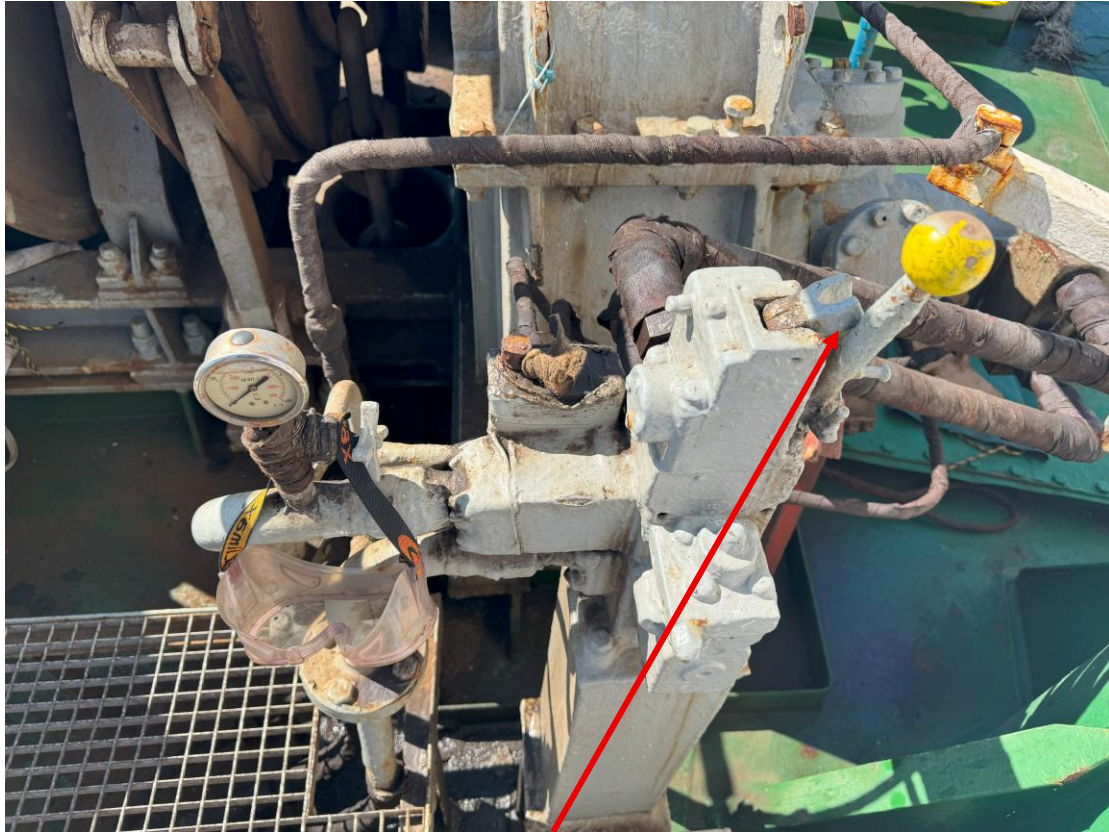
However, it was observed that contrary to proper procedures, the winch can be kept active by securing the lever with its safety catch. This action allows the drum to continue rotating without continuous manual activation of the lever. Figure 15.

***Fig15- View of lever held in position by safety catch***

- Include in the company SMS a specific risk assessment addressing the risks and hazards associated with working with mooring winches, as outlined in the OCIMF *Effective Mooring* guidelines and COSWP, explicitly considering the operational and safety risks posed by winches.
