HM Government
of Gibraltar

**Office of the Marine Accident
Investigation Compliance Officer**

Report on the investigation of the collision of

SM KESTREL and DIAMOND STAR II on

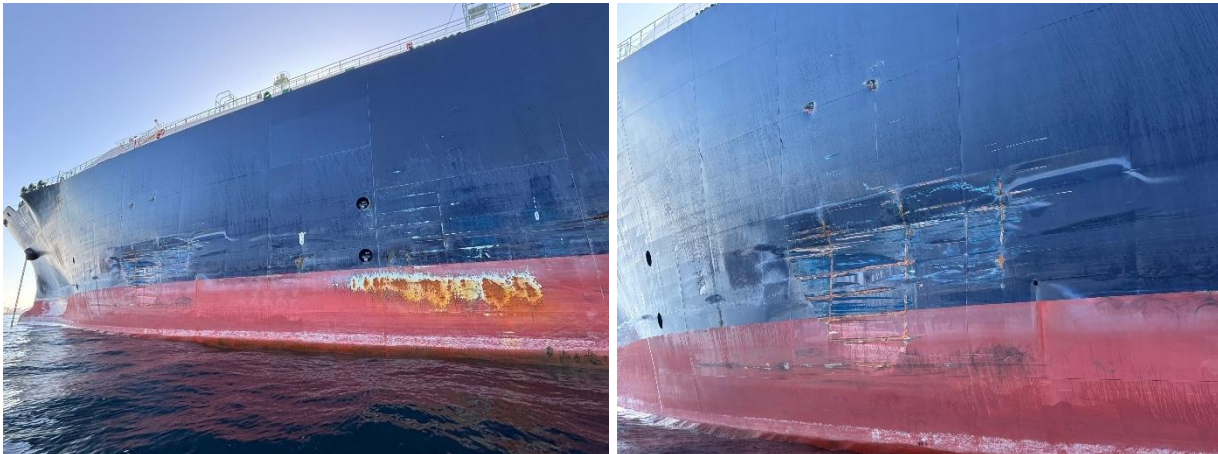
The following damages were observed and reported upon by attending Class Surveyor (see figure 3 & 4 for hull damage):

- Side shell plating indentation, from frame 83+3000mm to frame 87+1000mm, between middle stringer platform and lower stringer platform, with side shell longitudinal stiffeners in way affected, from 16th from main deck to 21st from main deck.
- Web frames affected: 84, 85, 86 and 87.
- Middle stringer platform plating found indented, from frame 84+1500mm to frame 87.

Figure 3 - View of Port side hull damage

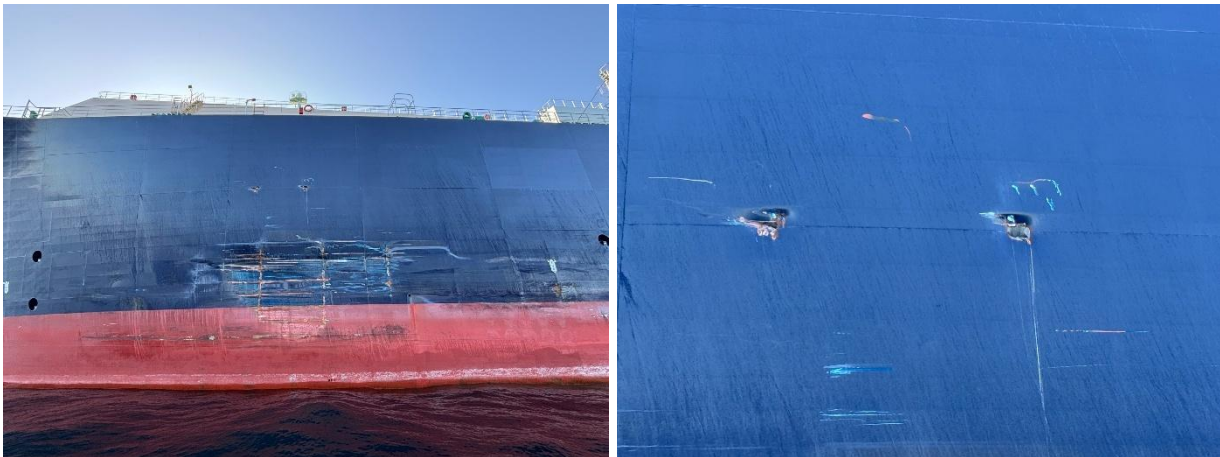
- Side shell plating found holed:
 - At location frame 85+1000mm, between side shell longitudinal stiffeners 10th and 11th from deck.
 - Hole of 500x500mm.
 - At location frame 86+500mm, between side shell longitudinal stiffeners 10th and 11th from deck.
 - Hole of 500x500mm. In way of frame 85, at 17th side shell longitudinal stiffener from deck.
 - Hole of 300x300mm.

Figure 4 - General View of Port side hull damage & breached / holed hull

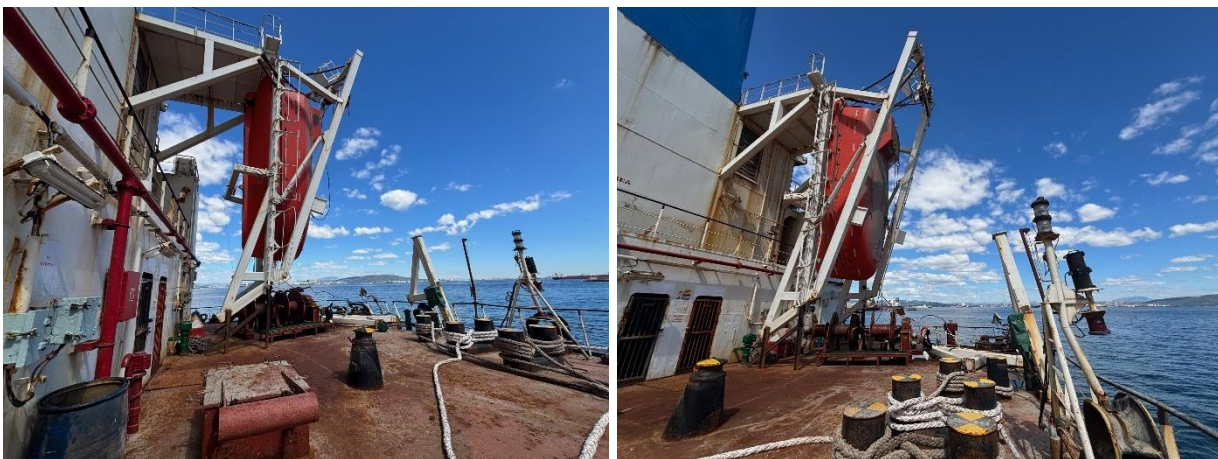
- Aft poop deck and transom plating found deformed /buckled between from – 5 to 0 with two holes in upper locker starboard.
- Crack with hole in the upper deck corner starboard side / aft and at aft deck midship coinciding with 2nd vertical frame from starboard side.
- Freefall lifeboat & davit found damaged. Davit connection to main deck found damaged and detached.
- Panama chock found damaged.

Figure 5 - General View of freefall lifeboat & davit secured by welding after damage

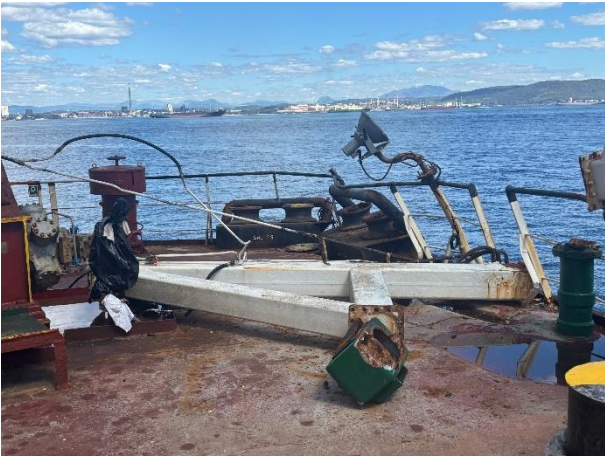
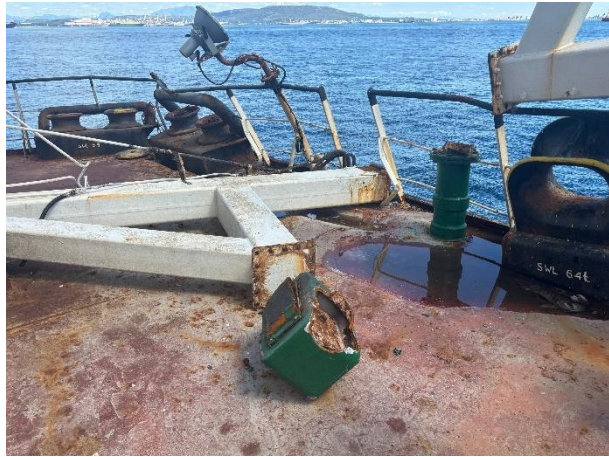
Figure 6 - General View of davit support structure collapsed & aft peak tank air pipe damaged / fractured

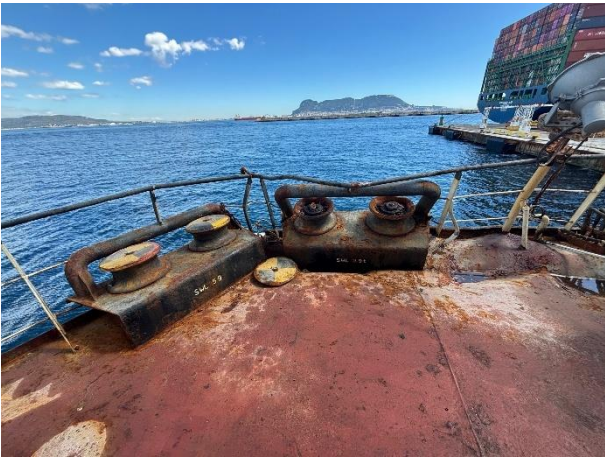
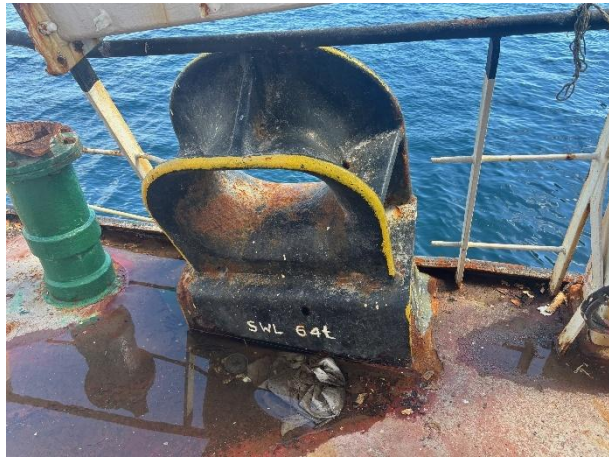
Figure 7 - General View of mooring equipment damaged

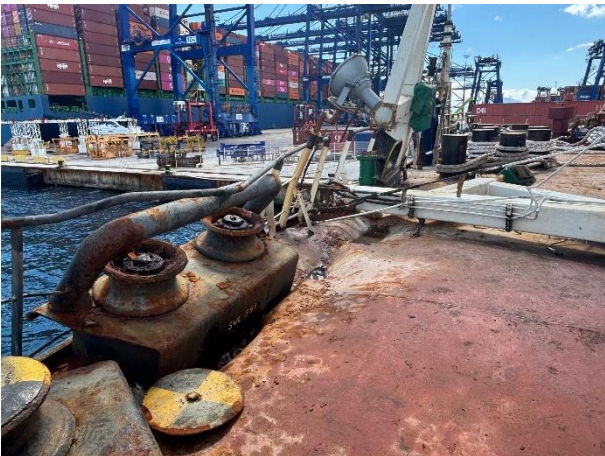
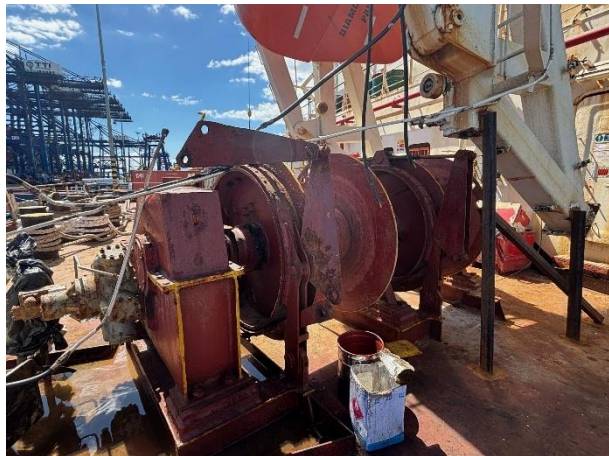
Figure 8 - General View aft deck deformed & buckled / Mooring windlass brake structural damage

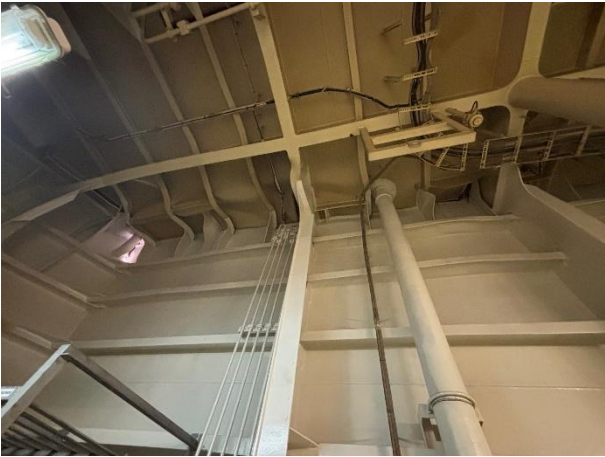
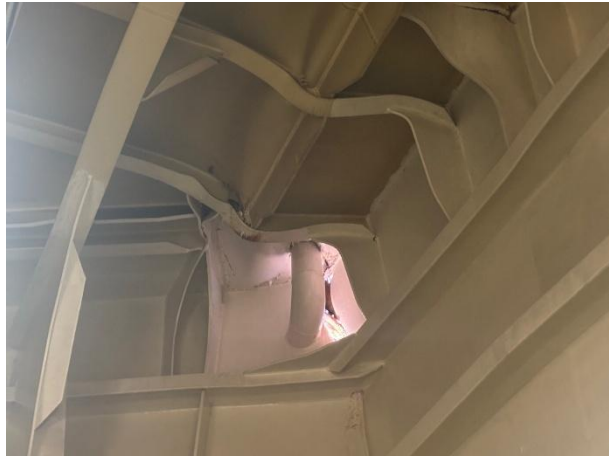
Figure 9 - General View internally of aft Stbd side quarter deformed / buckled / holed

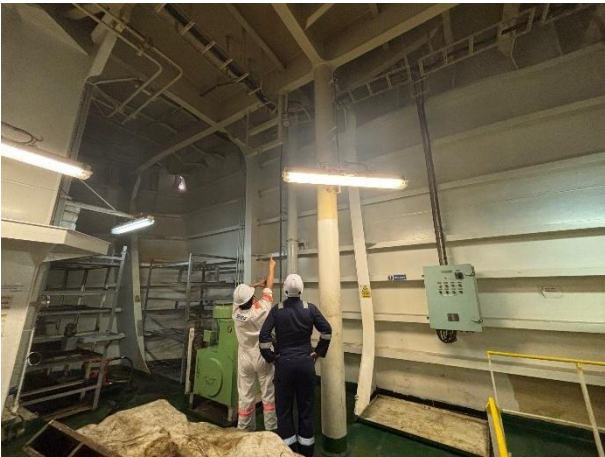
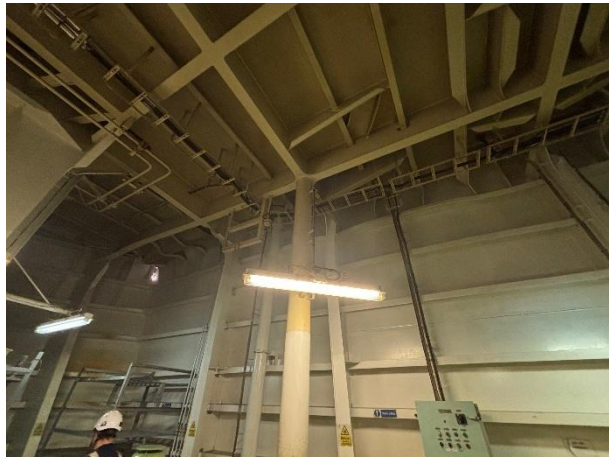
Figure 10 - General View internally aft transom plating deformed / buckled

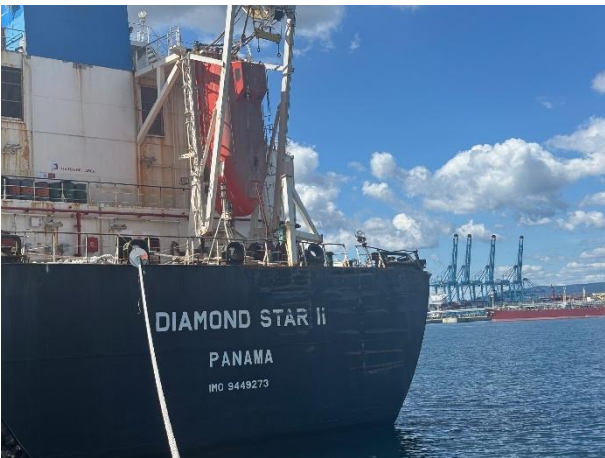
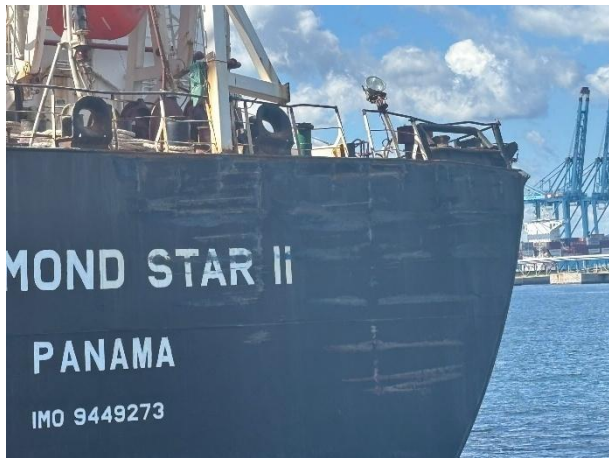
Figure 11 - General View of aft transom plating deformed / buckled

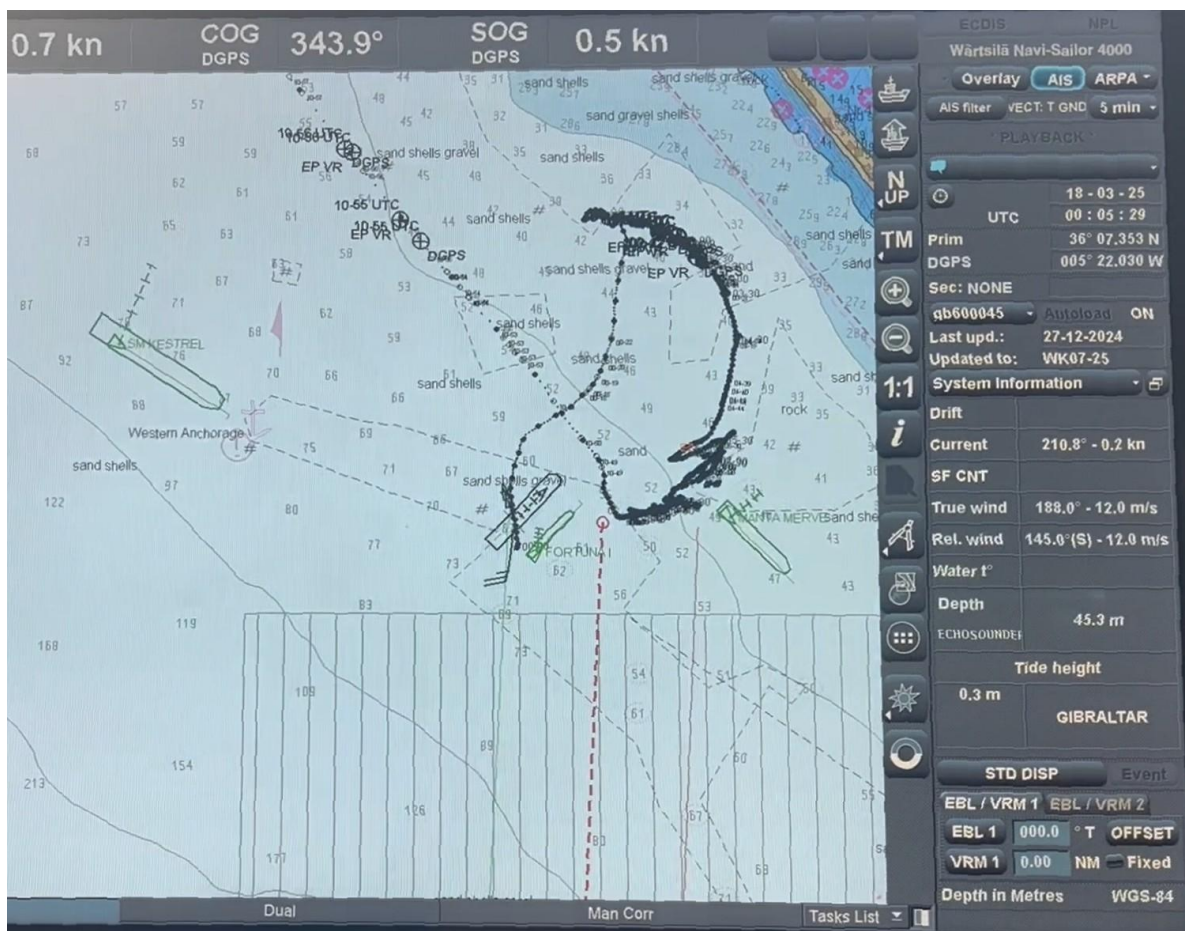
Figure 19 Positions of 'SM Kestrel' when anchor away at 01:05 LT 00:05 UTC underway at 21:52:00

At approximately 0105 LT, with the anchor aweigh, the vessel began experiencing continuous drift to port caused by strong beam winds, significantly reducing manoeuvrability. At this time, the distance to the western breakwater was approximately 0.5 nautical miles and decreasing (figure 19).

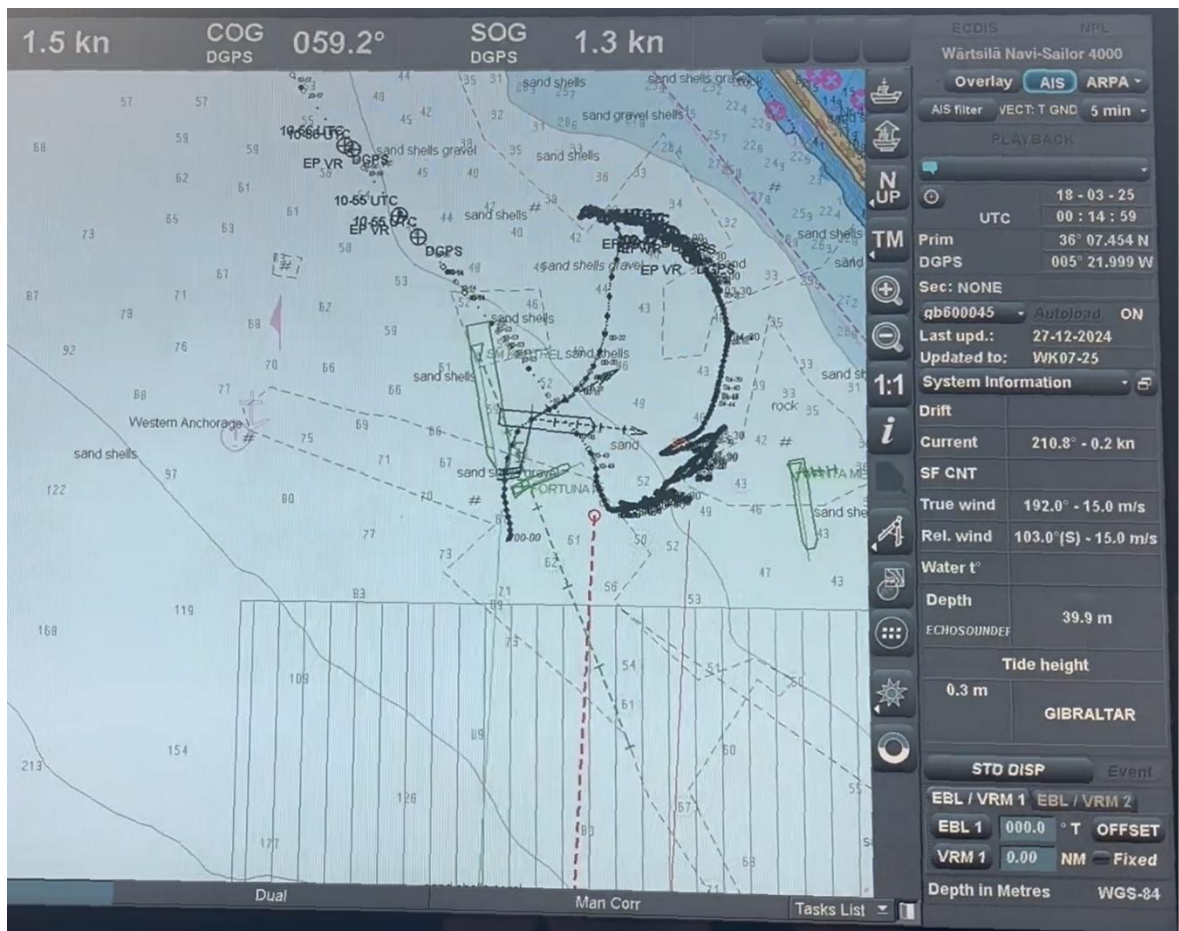
Figure 20 Positions of 'SM Kestrel' at time of collision taken from the ECDIS of the "Diamond Star II" at 01:15 LT 00:15 UTC

Subsequently, the vessel collided with the stern of the anchored vessel *DIAMOND STAR II*. Master of the SM Kestrel recorded within the deck and bell books contact to have taken place at 01:15 LT (see figure 20).
