HM Government of Gibraltar

Report on the investigation of the accident on board

Service Launch “SAMMY ONE” and Fishing Boat “KEITH”

07 February 2025

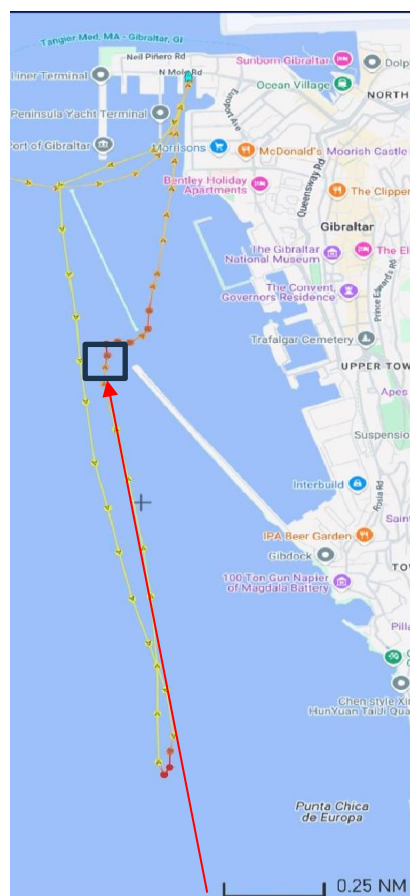
Fig. 7 - Approximate position where collision took place

The crew member on Keith became aware of the risk of collision with the Sammy One on hearing the sound of her engines and then spotting her at a distance of approximately 30 meters. Crew on the Keith altered course to starboard, avoiding a head-on collision, however, too late to avoid the collision. Noticing that the collision could not be avoided, crew on the Keith shifted from the aft steering position to amidships to avoid the possibility of being struck by the Sammy One's port hull.

Sammy One's Boat Master, on sighting Keith at a distance of 10/15 meters slowed down and also stated to have altered course to starboard, however also too late to avoid colliding with Keith's Port Quarter.

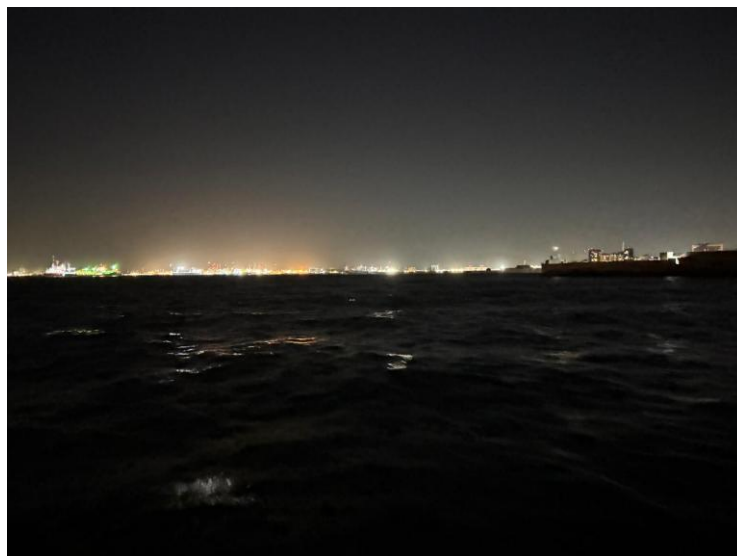
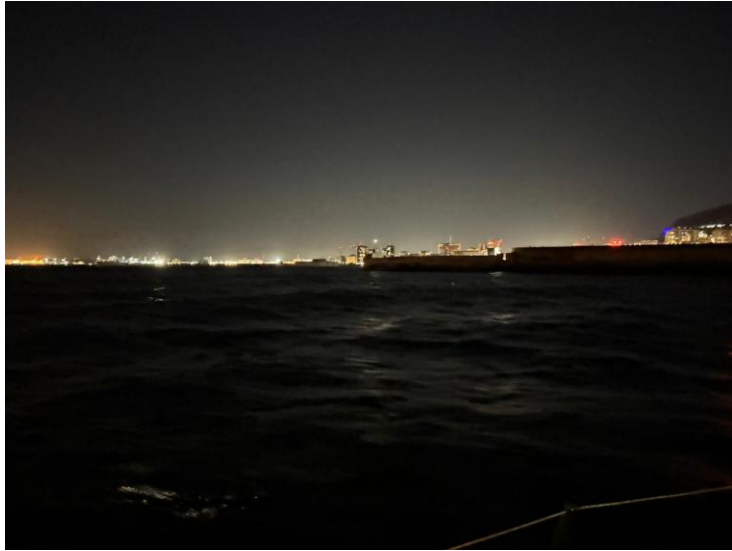
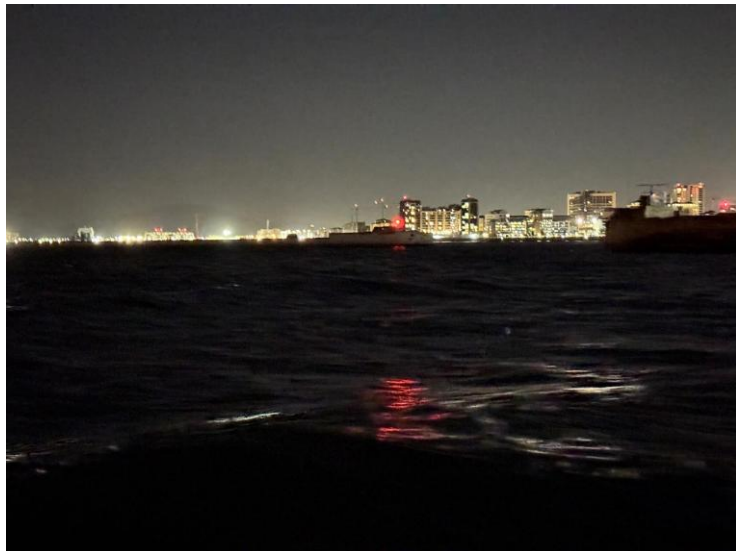
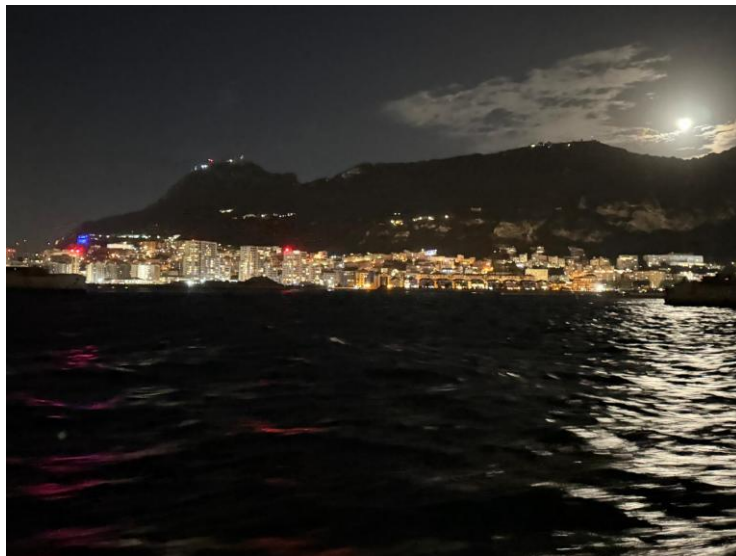
At the time of the incident it was still dark (dawn), visibility good, sea state calm. The investigation also identified the possibility that Sammy One's visibility may have been obscured by the presence of background light / shoreside light pollution. (See 4 photos below, showing presence of background light approaching Southern Entrance steaming from the south in a near northerly heading.)

- Issue a safety bulletin alerting mariners to the hazards associated with navigating in close proximity to harbour entrances and keeping a good lookout (COLREG Rule 5) and awareness of the possible effects the presence of background lights may have on visibility.

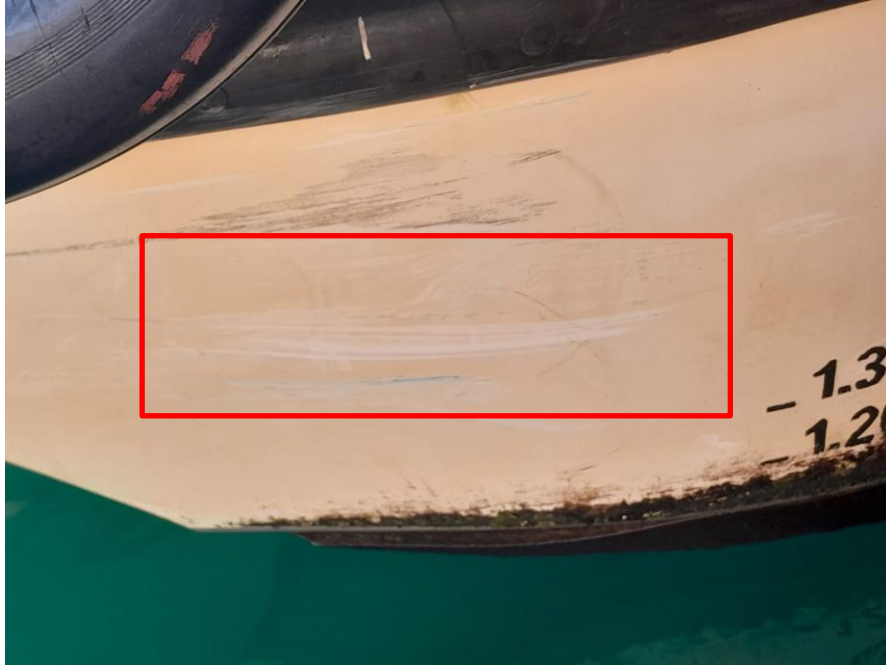
Fig. 8 – Damage sustained to SAMMY ONE Port Hull

The Sammy One's port bow hull suffered minor contact damage IWO of scratches to the gel coats surface. (see figure 8).

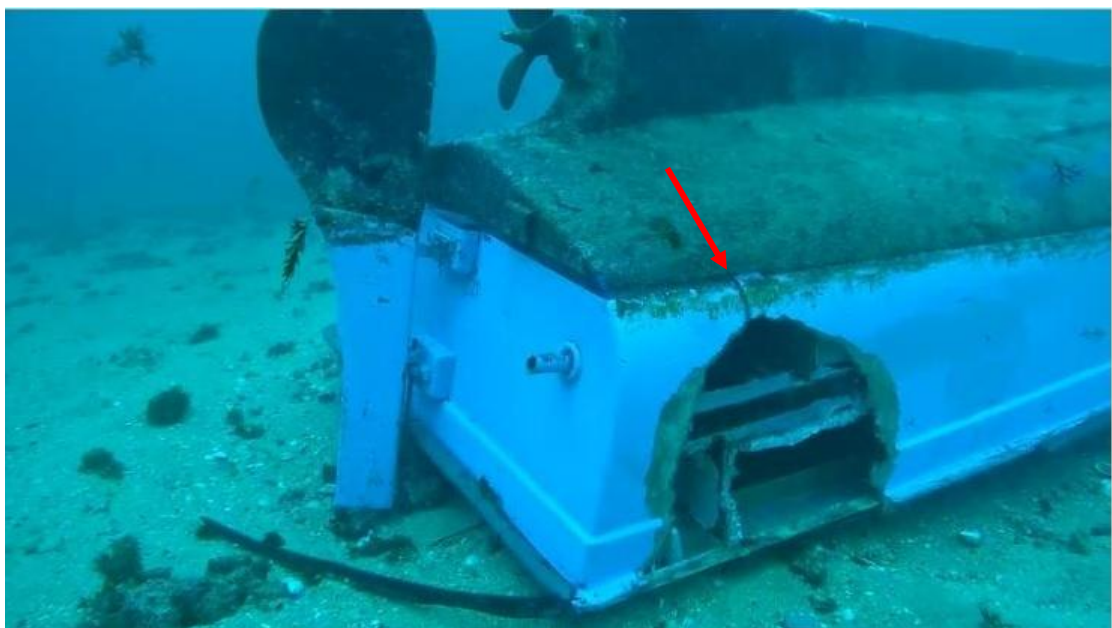
Fig. 9 – Damage sustain to Keith Port side quarter

Immediately on impact Keith suffered contact damage in way of the port quarter just above the waterline. As the live well is positioned on the port side of the boat, its pump was immediately switched off to reduce the list.

Keith's hull was holed in way of her Port quarter, see images taken by divers once located on the seabed. Hull fracture across the underside of the hull towards the centreline keel.

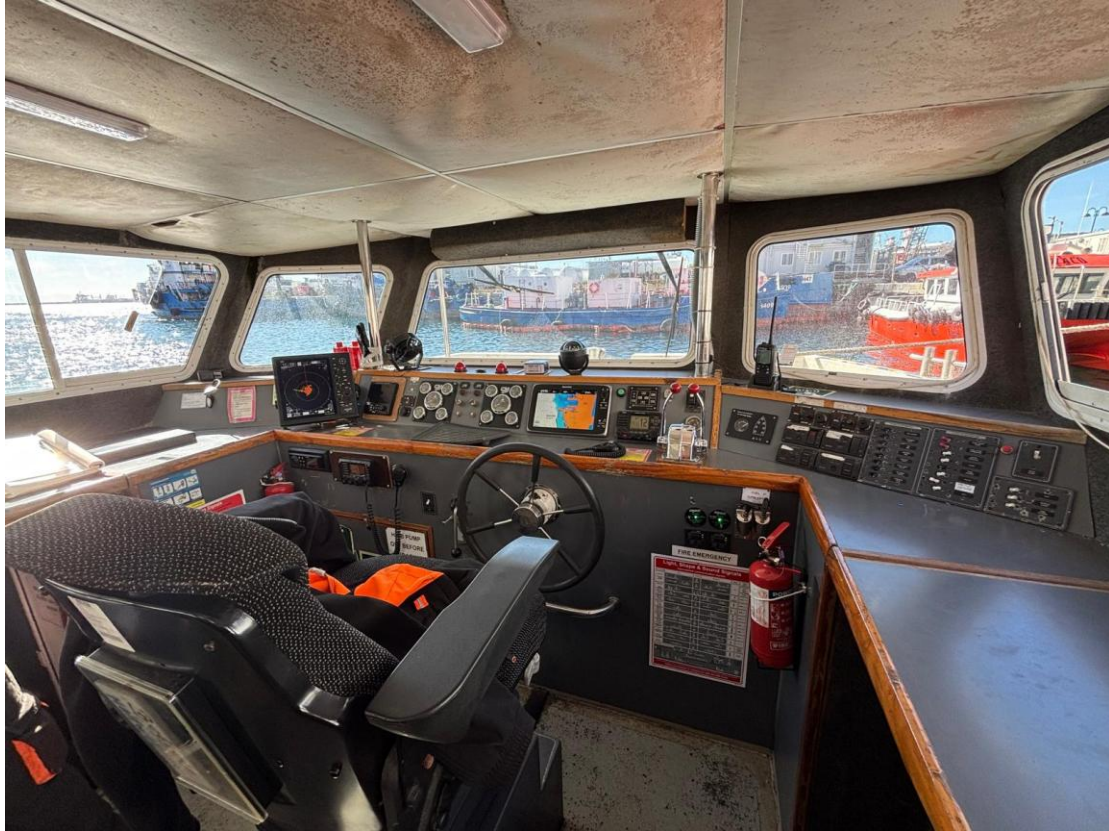
Fig. 10 - View of Sammy One's wheelhouse layout and visibility

From the helm position in the wheelhouse, the Boat master of the Sammy One had a clear sight of the sea surface and ahead of the vessel.
