# Government of Gibraltar

## Preliminary Flood Risk Assessment

Final Report

January 2011

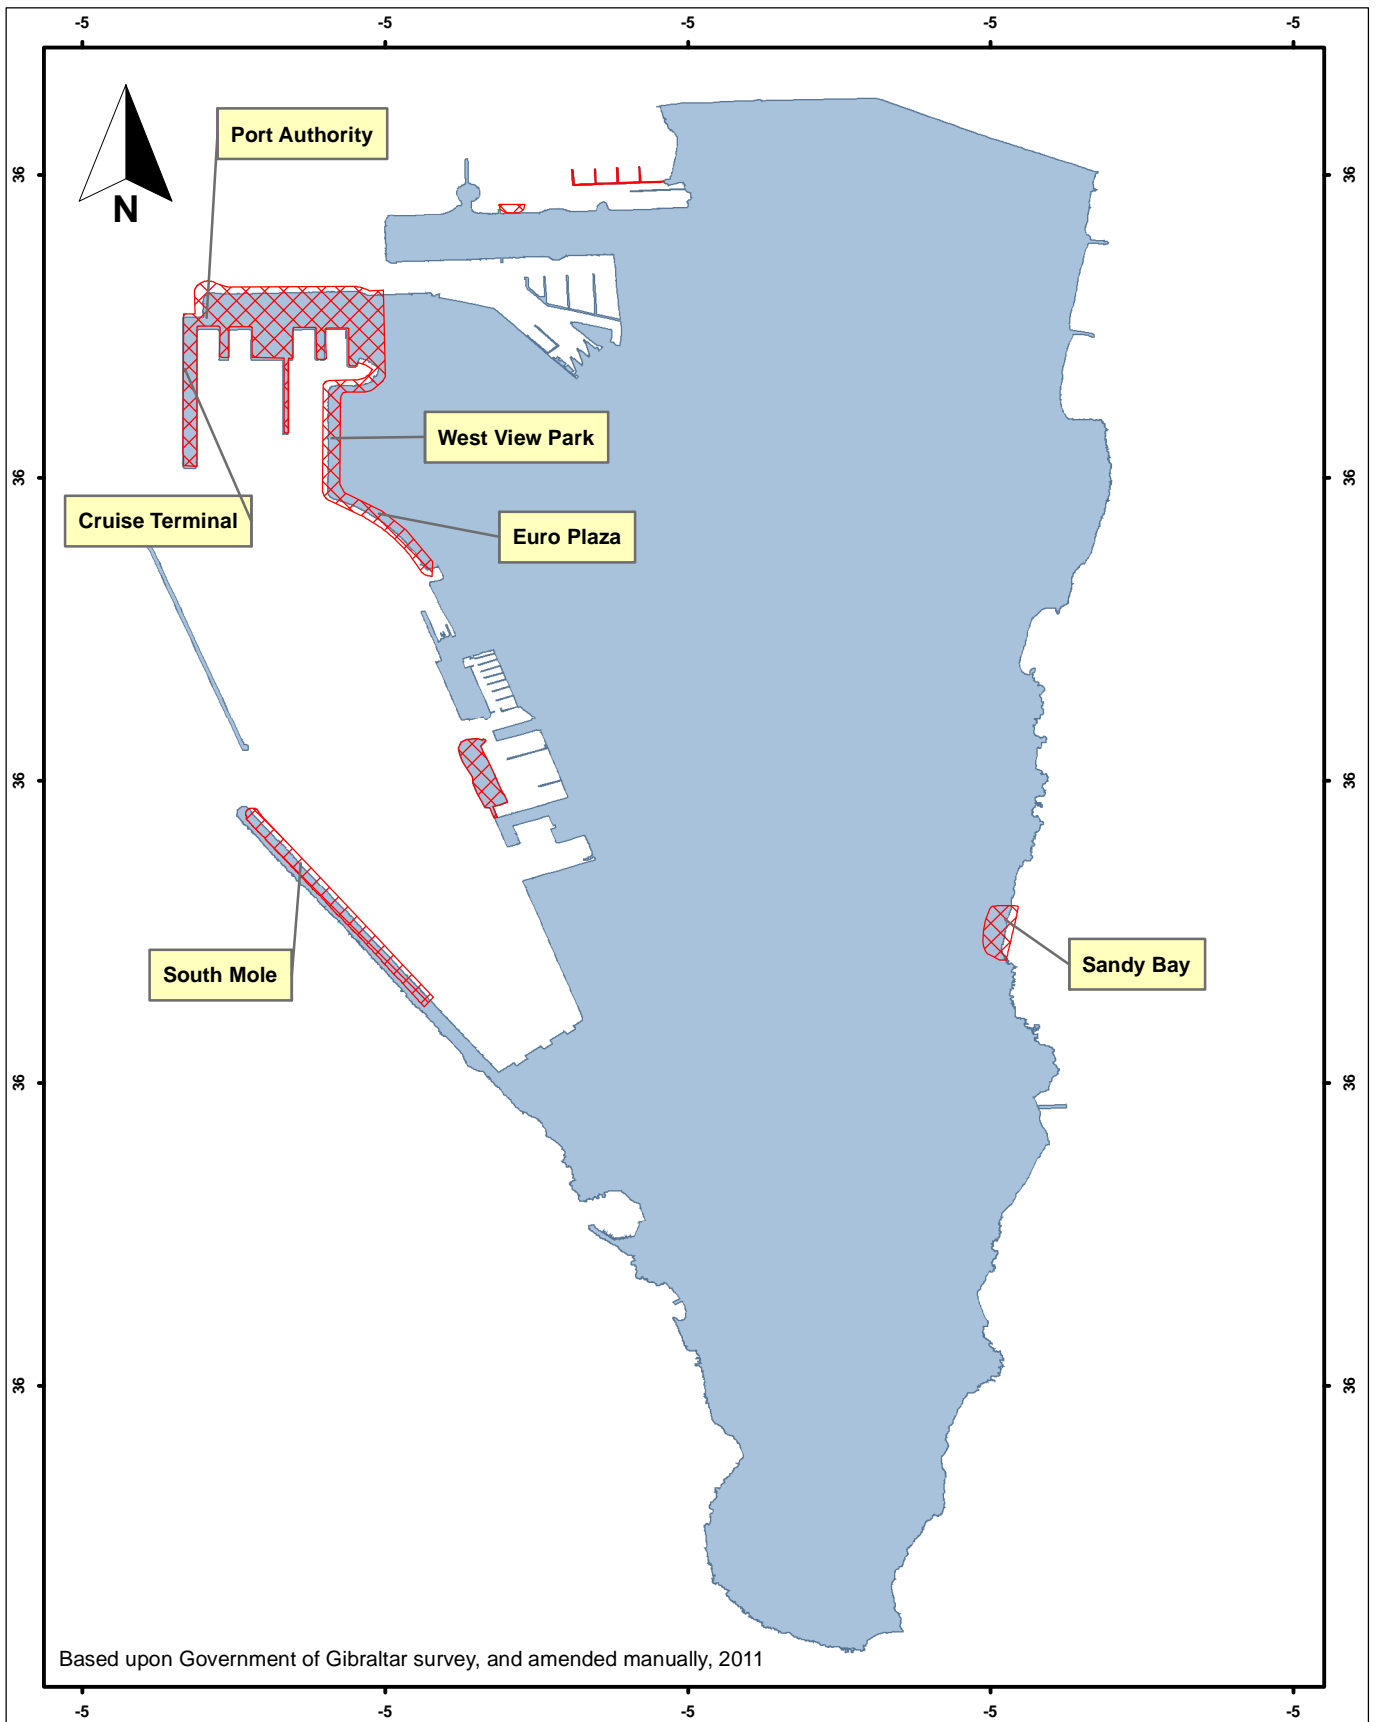
Records of storm surge flood damage October 2008

Figure 4.2 maps the locations where significant damage occurred as a result of the storm surge event in October 2008. It should be noted however that during this storm event, no residential properties were significantly damaged.

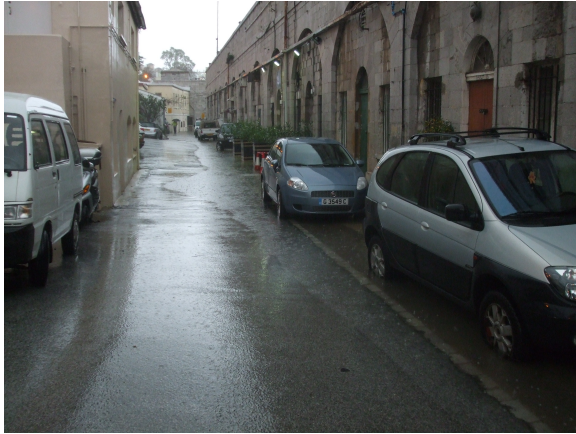
**Plate 1: Queensway and Wellington Front**

- **Queensway and Wellington Front.** Queensway is prone to surface water flooding along its entire reach especially between the Ragged Staff Roundabout and Wellington Front areas. It is thought that the surface water drainage system backs up, and is also subject to some minor collapses in the pipe network. During heavy downpours standing water will accumulate in many places, where there are predominantly impermeable surfaces combined with a potentially inadequate drainage system. A solution to the issue is currently being investigated. The photograph in Plate 1 shows flooding which occurred in January 2010;

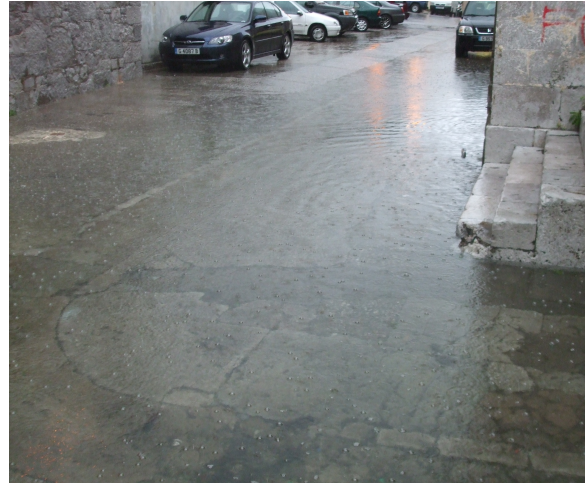
**Plate 2: Wellington Front**

- On the eastern, town side of Wellington Front, ground elevations are approximately 1 metre lower than Queensway and approximately 5 metres lower than land immediately to the east on Line Wall. This area provides car parking spaces for users of the clubs and organisations which occupy the vaults contained within Wellington Front. Flooding occurs in this area due to inadequate drainage which is currently being addressed (see Plate 2);

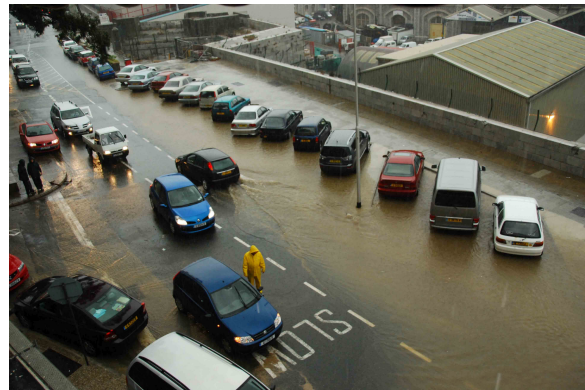
**Plate 4: Rosia Road**

- **Rosia Road.** Heavy rainfall during a storm event that occurred in October 2008 led to significant flooding of some of the coastal areas (described in more detail in section 4.2 below). The heavy rainfall caused flooding on Rosia Road near to Jumper's Bastion which significantly affected traffic movement. The photograph in Plate 4 shows sediment-entrained flood water on the road and car parking areas. The colour of the water is further indication that this run-off is likely to be generated uphill on the Rock, and that the steepness induces run-off, rather than permitting rain to infiltrate into the ground above the town.

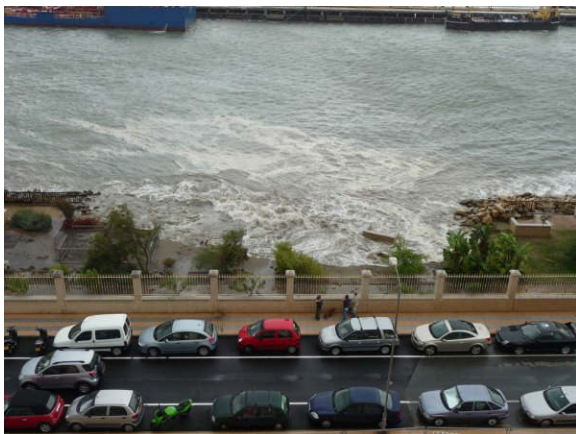
**Plate 5: West View Park**

On 10 October 2008 a particularly low pressure storm combined with a high tide and caused a severe storm surge. This caused one of the most significant flooding events in Gibraltar in recent history. Flooding occurred in many coastal areas of Gibraltar as a result of the sea overtopping the sea walls in the harbour area and inundating the east coast settlements. Substantial damage was caused to some buildings in the coastal area. The most damage occurred in the area of the Europlaza residential building and the car parking areas between Morrisons supermarket and the harbour (WestView Park), where the sea wall and rock revetments were breached. Sea water inundated the area and the underground car park beneath the Europlaza, and the loose rocks from the breached defences also caused some of the building damage. This location in the harbour is considered to be currently the most exposed location to storm surges and as a result suffered from the full force of the storm. The photographs in Plates 5 and 6 show the damage to the sea defences at West View Park and the Europlaza building.

Apart from the physical damage caused by the storm surge, economic impacts were also observed predominantly due to the damage caused to sea defences alongside West View Park and the East side. The cost of repair to the harbour and Western sea defences sums up to £10 million and accounts for the sum of individual work packages that were required. Some of this repair work is still ongoing. An additional £200,000 was spent on the rock armour at Sandy Bay to prevent further damage to the housing complex immediately behind Sandy Bay known as Both Worlds.

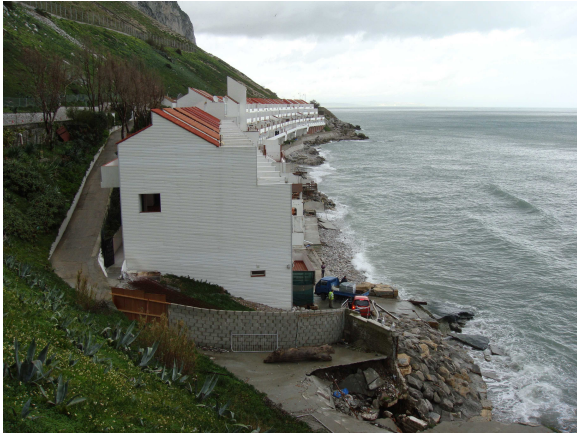
**Plate 7: Sandy Bay**

The eastern coast of Gibraltar is much less developed. However, the two main residential areas at Catalan Bay and Sandy Bay also experienced flood and storm damage during the October 2008 event, and are generally subject to storm damage from storm surges and from coastal erosion. On this side, the Rock slopes steeply into the sea therefore the two settlements at Catalan Bay and Sandy Bay are backed by the steep slopes and are fronted by the sea. Wave action against the steep shore results in gradual erosion of the coastline. During the 2008 event, the beach in front of Sandy Bay was completely inundated and sea defences were damaged. Damage did occur at the sewage pumping station which suffered irreparable structural damage. Plates 7 and 8 show the proximity of the development at Sandy Bay to the shore with collapsed sea defences and Catalan Bay.

As discussed above, the sewage pumping station at Sandy Bay was damaged, impacting on sewerage services to the Both Worlds complex on the eastern side of Gibraltar. Works carried out include placing rock armour along the front of the existing retaining wall along Sandy Bay beach, demolishing damaged structures and repairing the sewage infrastructure at Sandy Bay.

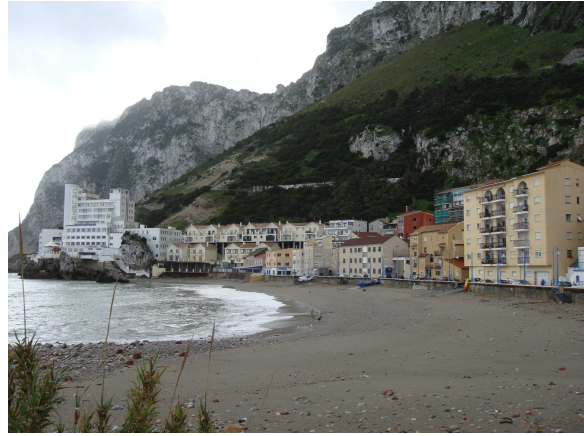
**Plate 8: Catalan Bay**

Catalan Bay	Storm Surge	Wave action resulted in flooding of this area during the 2008 event	There have been no significant consequences to human health, the economy, the environment or to cultural heritage from flooding at this location.
Sandy Bay	Storm Surge	During the 2008 event, the beach in front of Sandy Bay was completely inundated and sea defences were damaged. The sewage pumping station at this location suffered irreparable structural damage.	There have been no significant consequences to human health, the environment or to cultural heritage from flooding at this location. Some consequences to the economy resulted from the 2008 event, from the cost of repair to structural damage in this area.
