The Main Guard
13, John Mackintosh Square,
Gibraltar.
Headquarters for the Gibraltar Heritage Trust
Repairs, Additions and Alterations
Drg No 7
SURVEY
Roof Plan
scale 1: 50. date May 2007
J. S. Langdon BArch.

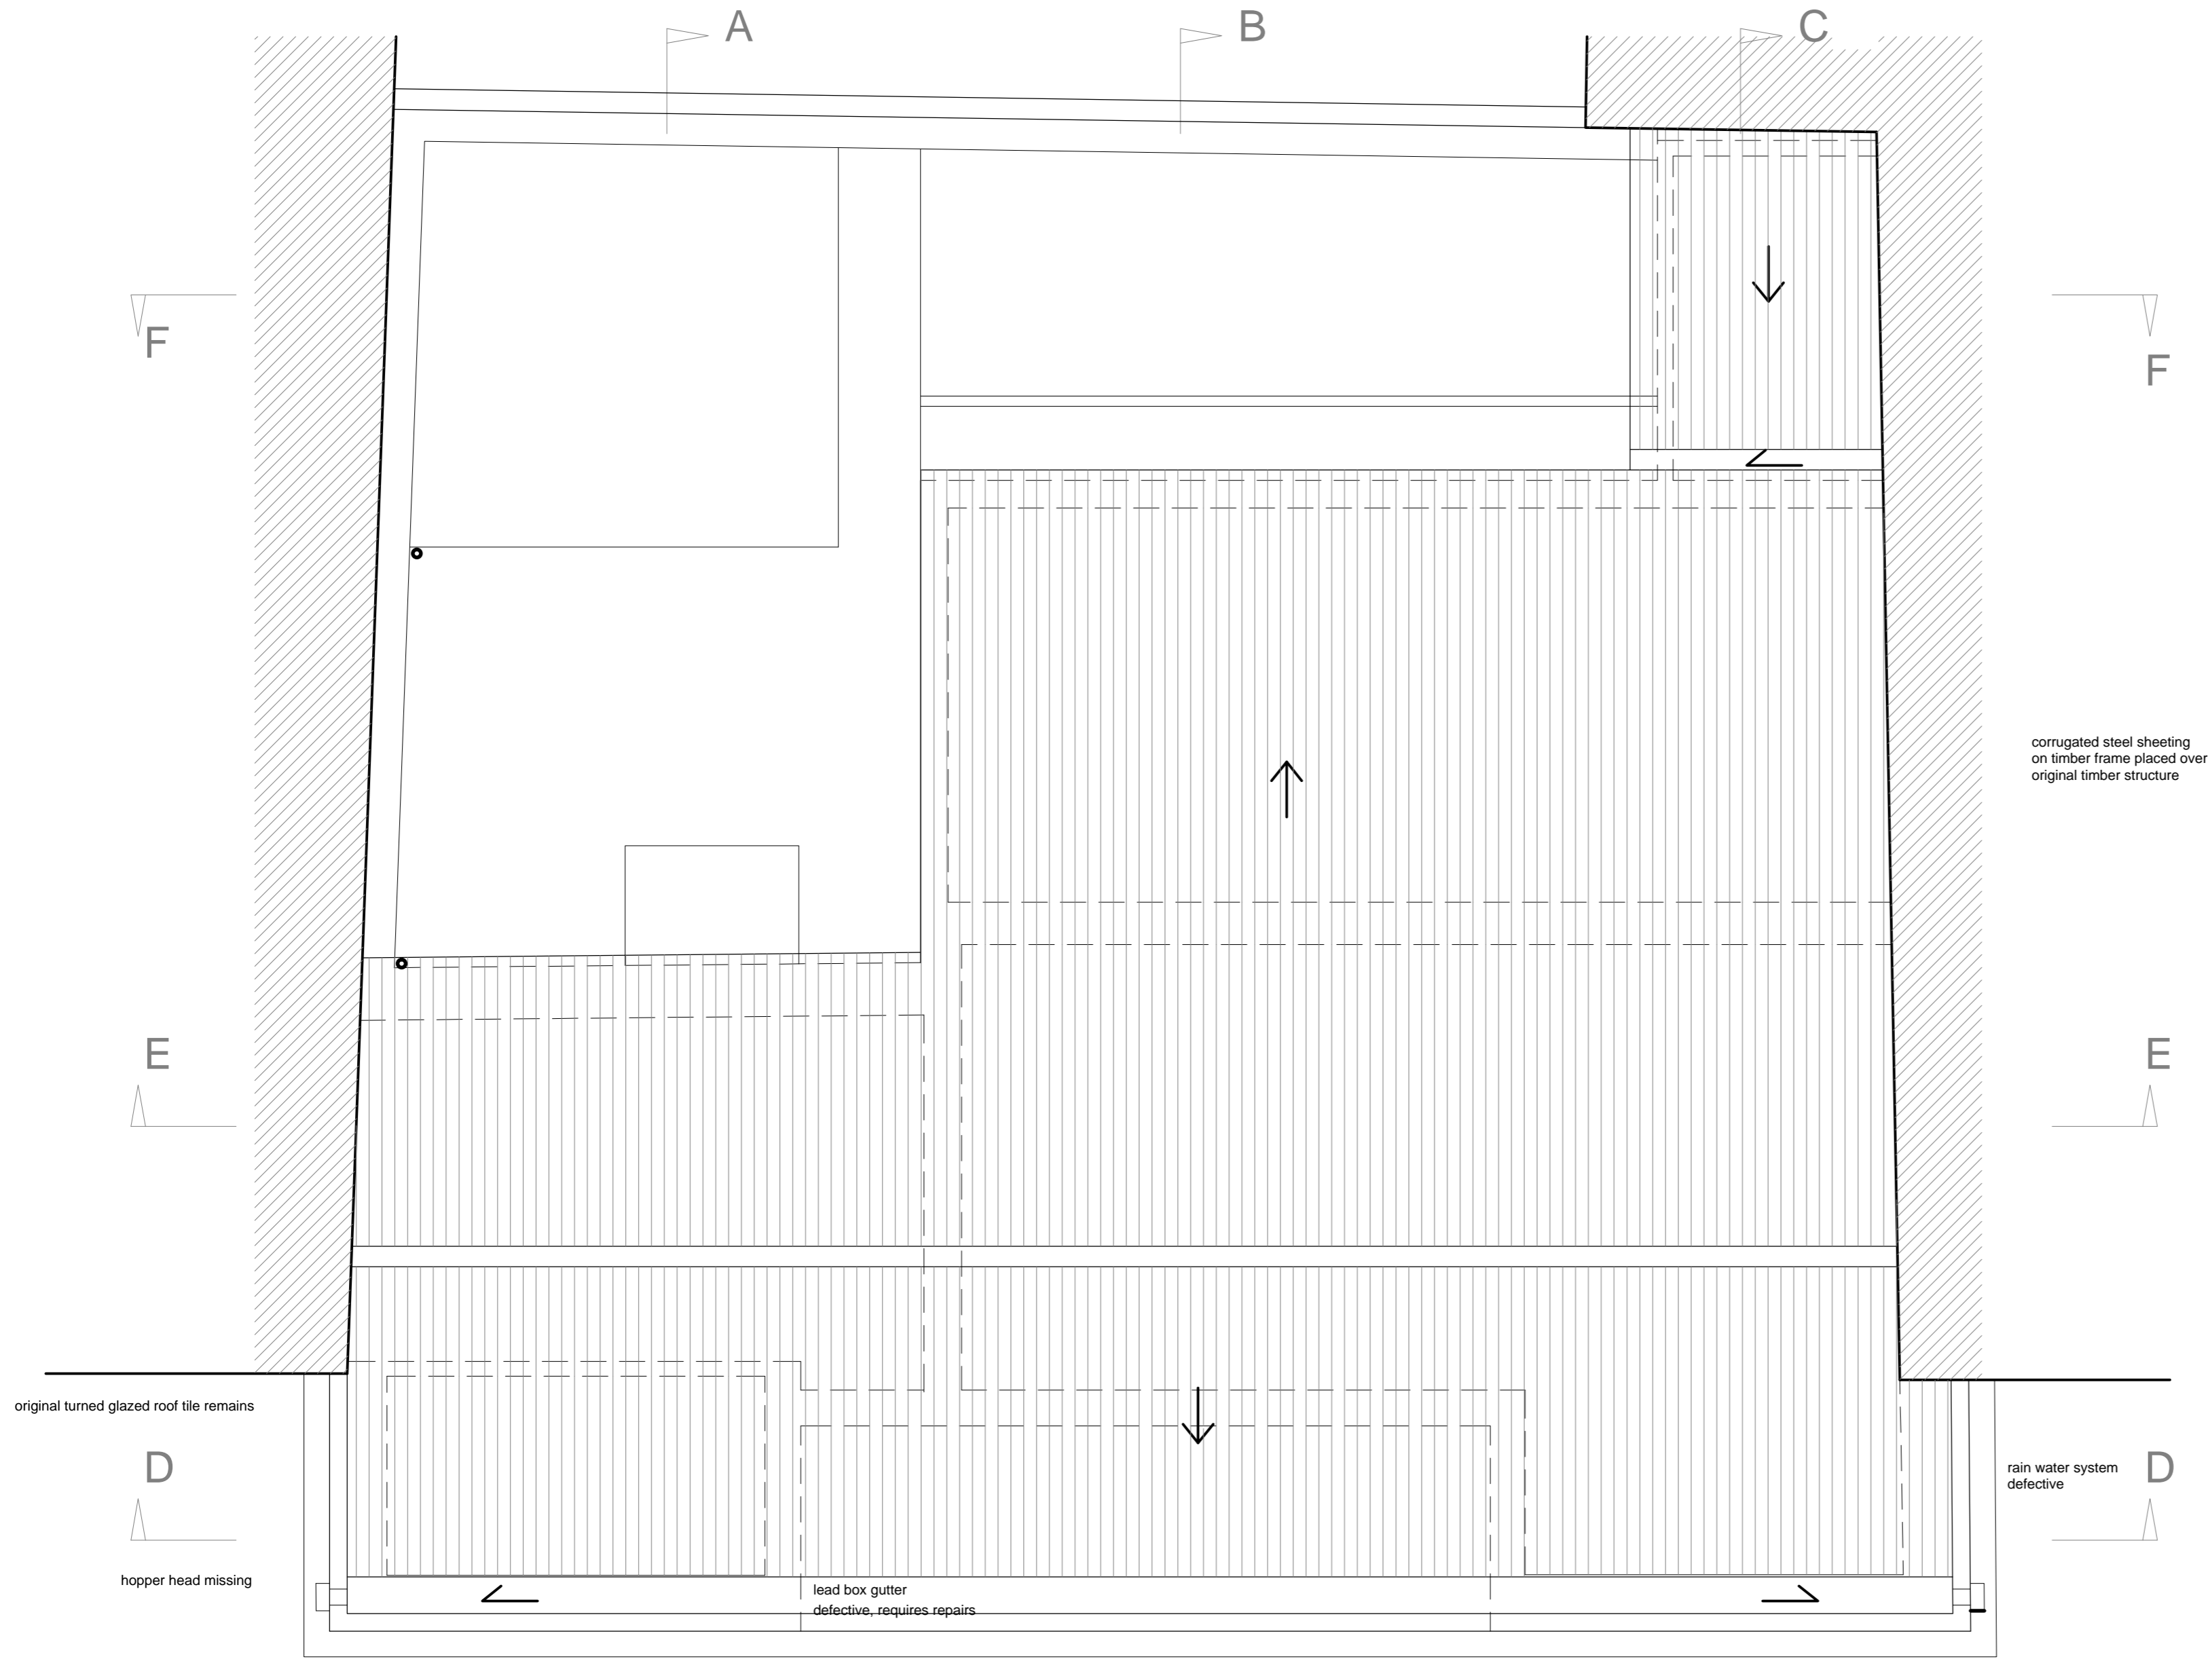
ROOF PLAN

corrugated steel sheeting
on timber frame placed over
original timber structure

original turned glazed roof tile remains

D
hopper head missing

lead box gutter
defective, requires repairs

rain water system
defective
