The Main Guard
John Mackintosh Square,
Gibraltar.

A Report on the Proposed Repairs, Additions and Alterations
for
The Gibraltar Heritage Trust
prepared by
J.S. Langdon B.Arch.
dated
January 2006

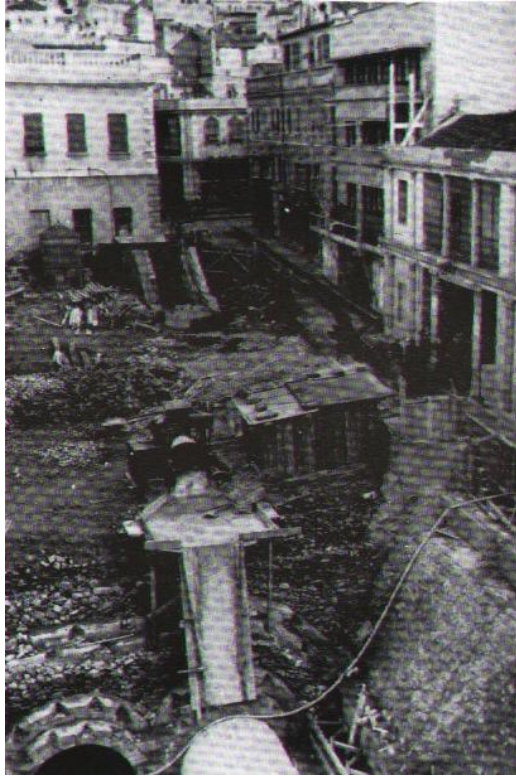
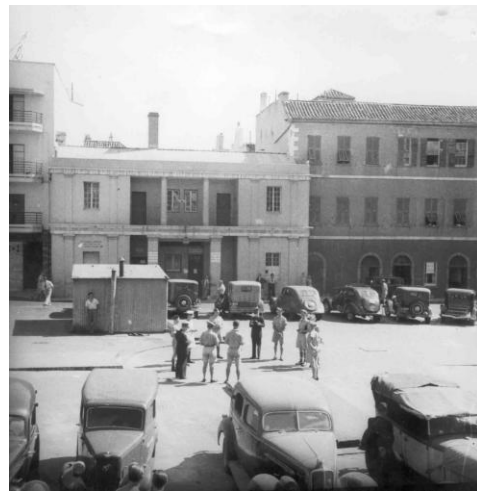
The condition of the façade is not bad considering the number of years of neglect and unsympathetic alterations, such as the enclosure of the ground floor loggia, telephone and electricity cables and brackets. Beneath thick layers of paint, the plaster or stone mouldings are still evident and the original casement windows, as seen on the Carter prints, are still in place on the upper floor.

The ground floor of the façade to John Mackintosh could date back to before 1748. The restoration will include opening up the loggia on the ground floor, retaining the widened space between the two central columns and replacing the windows on the N-W corner as seen on the Carter print. The whole façade will be stripped of cables and paint and the plasterwork or stone work examined and repaired to its original condition. This will be assessed when the fabric is exposed. Improvements will be made in respect of lighting and signage.
