DEMOLITION METHOD STATEMENT

ROYAL GIBRALTAR YACHT CLUB (RGYC)

GIBRALTAR

METHOD STATEMENT FOR THE DEMOLITION OF THE RGYC. GIBRALTAR.

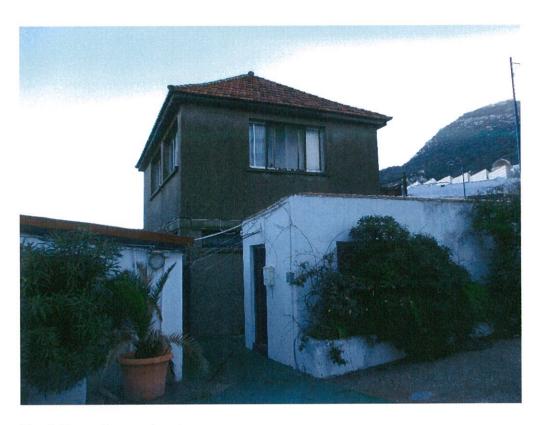
Fig 1 Two storey structure

- d) Demolish two storey building F by mechanical means, grub out ground floor slabs and foundations and cart away to tip.
- e) Demolish two storey building G by mechanical means but leave 1m buttresses 2.4m high to support boundary wall H.

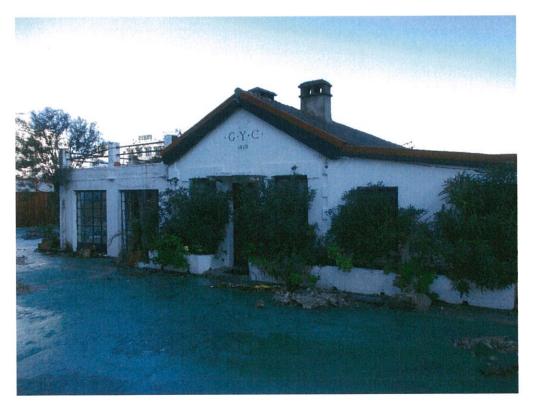
Fig 2 Single storey club house south elevation

- a) Working from within the site demolish the clubhouse using mechanical plant commencing with Building A and working through to buildings B and C and grub out ground floor slabs and foundations. Cart away all materials to tip.

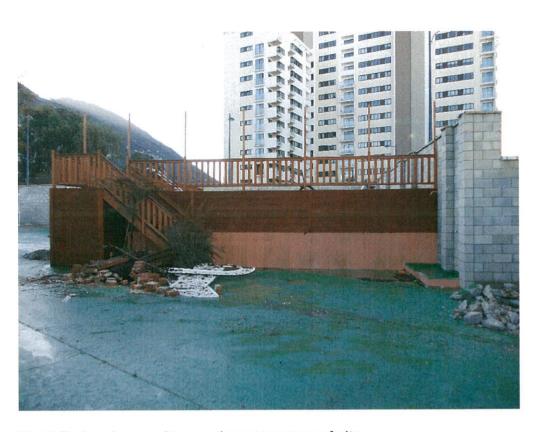
Fig 5 Swimming pool to south west corner of site

- a) Remove all hazardous materials from site in accordance with specialist contractors recommendations.
- b) Carefully dismantle existing swimming pool structure and set aside for re-use.
- c) Carefully open up a trial hole at the base of the blockwork boundary wall between the RGYC and the sea scouts property to establish the depth and type of foundations.
- d) Carry out a condition survey of the sea scouts premises prior to commencement of works.

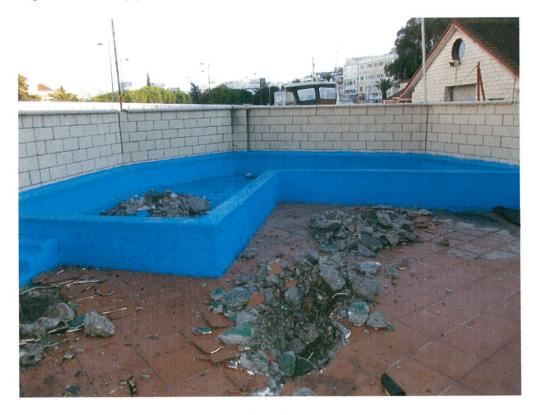
Fig 6 Paddling pool to North end of site

- g) Carefully break out paddling pool marked J to the North of the site to avoid damage to boundary wall of sea scouts property.
- h) Break out the hardstanding over the whole of the site (but not the entrance ramp off Queensway) down to a level of 300mm below existing ground level and cart away arisings to tip. Findings of investigations discussed in para 5(c) will determine if this will result in undermining of boundary wall foundations. If undermining is unavoidable consult with Engineer and Project Manager before proceeding.

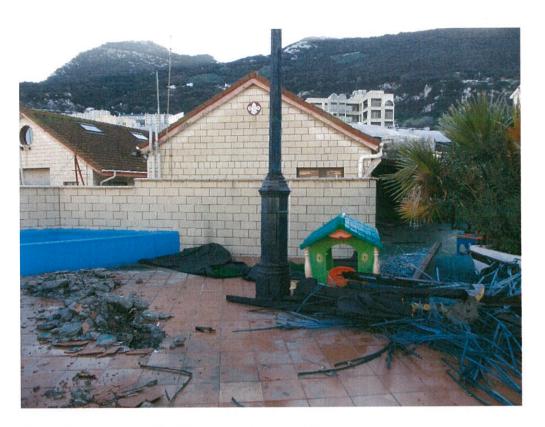
Fig 7 Boundary wall with sea scouts property

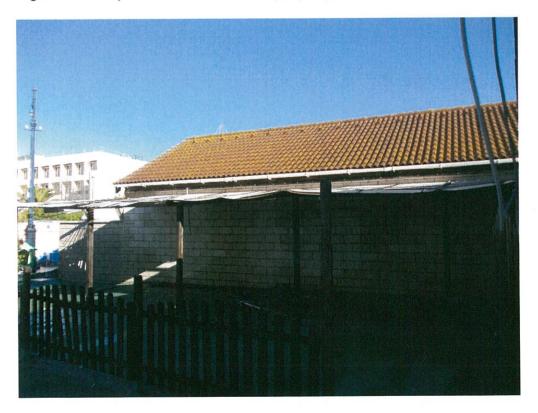
Fig 8 Timber lean too structure against sea scouts building

- b) Carefully dismantle timber lean too structure D so as not to cause any damage to the sea scouts building.
- c) Carefully dismantle building E partly by mechanical plant and partly by hand tools where adjacent to the sea scouts building. Carefully grub out ground floor slabs and foundations so as not to cause any damage to the adjacent sea scouts building. Cart away all materials to tip.

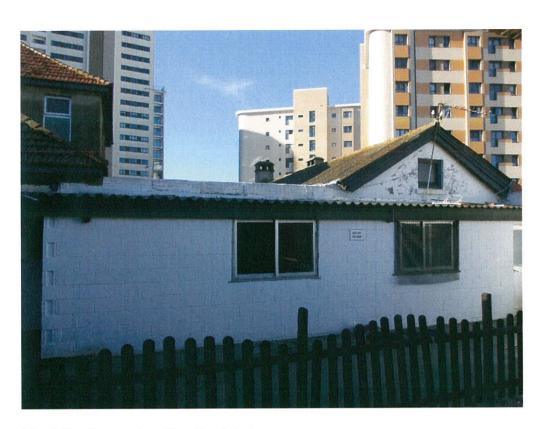
Fig 9 Northern elevation to club house

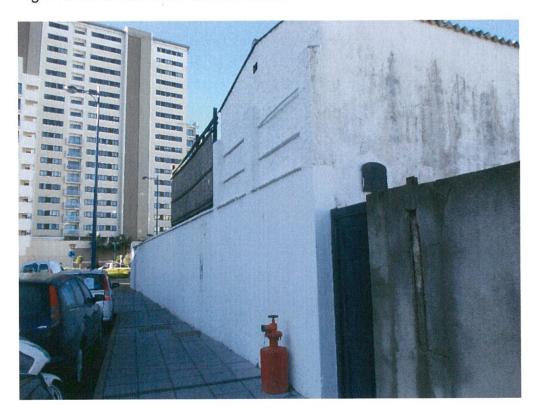
Fig 10 Boundary with Qeensway

- f) Carefully demolish Queensway boundary wall H and all remainder single storey structures adjacent to the wall. Grub out ground floor slabs and foundations. Cart away all arisings to tip.
