Ground Floor Plan

First Floor Plan

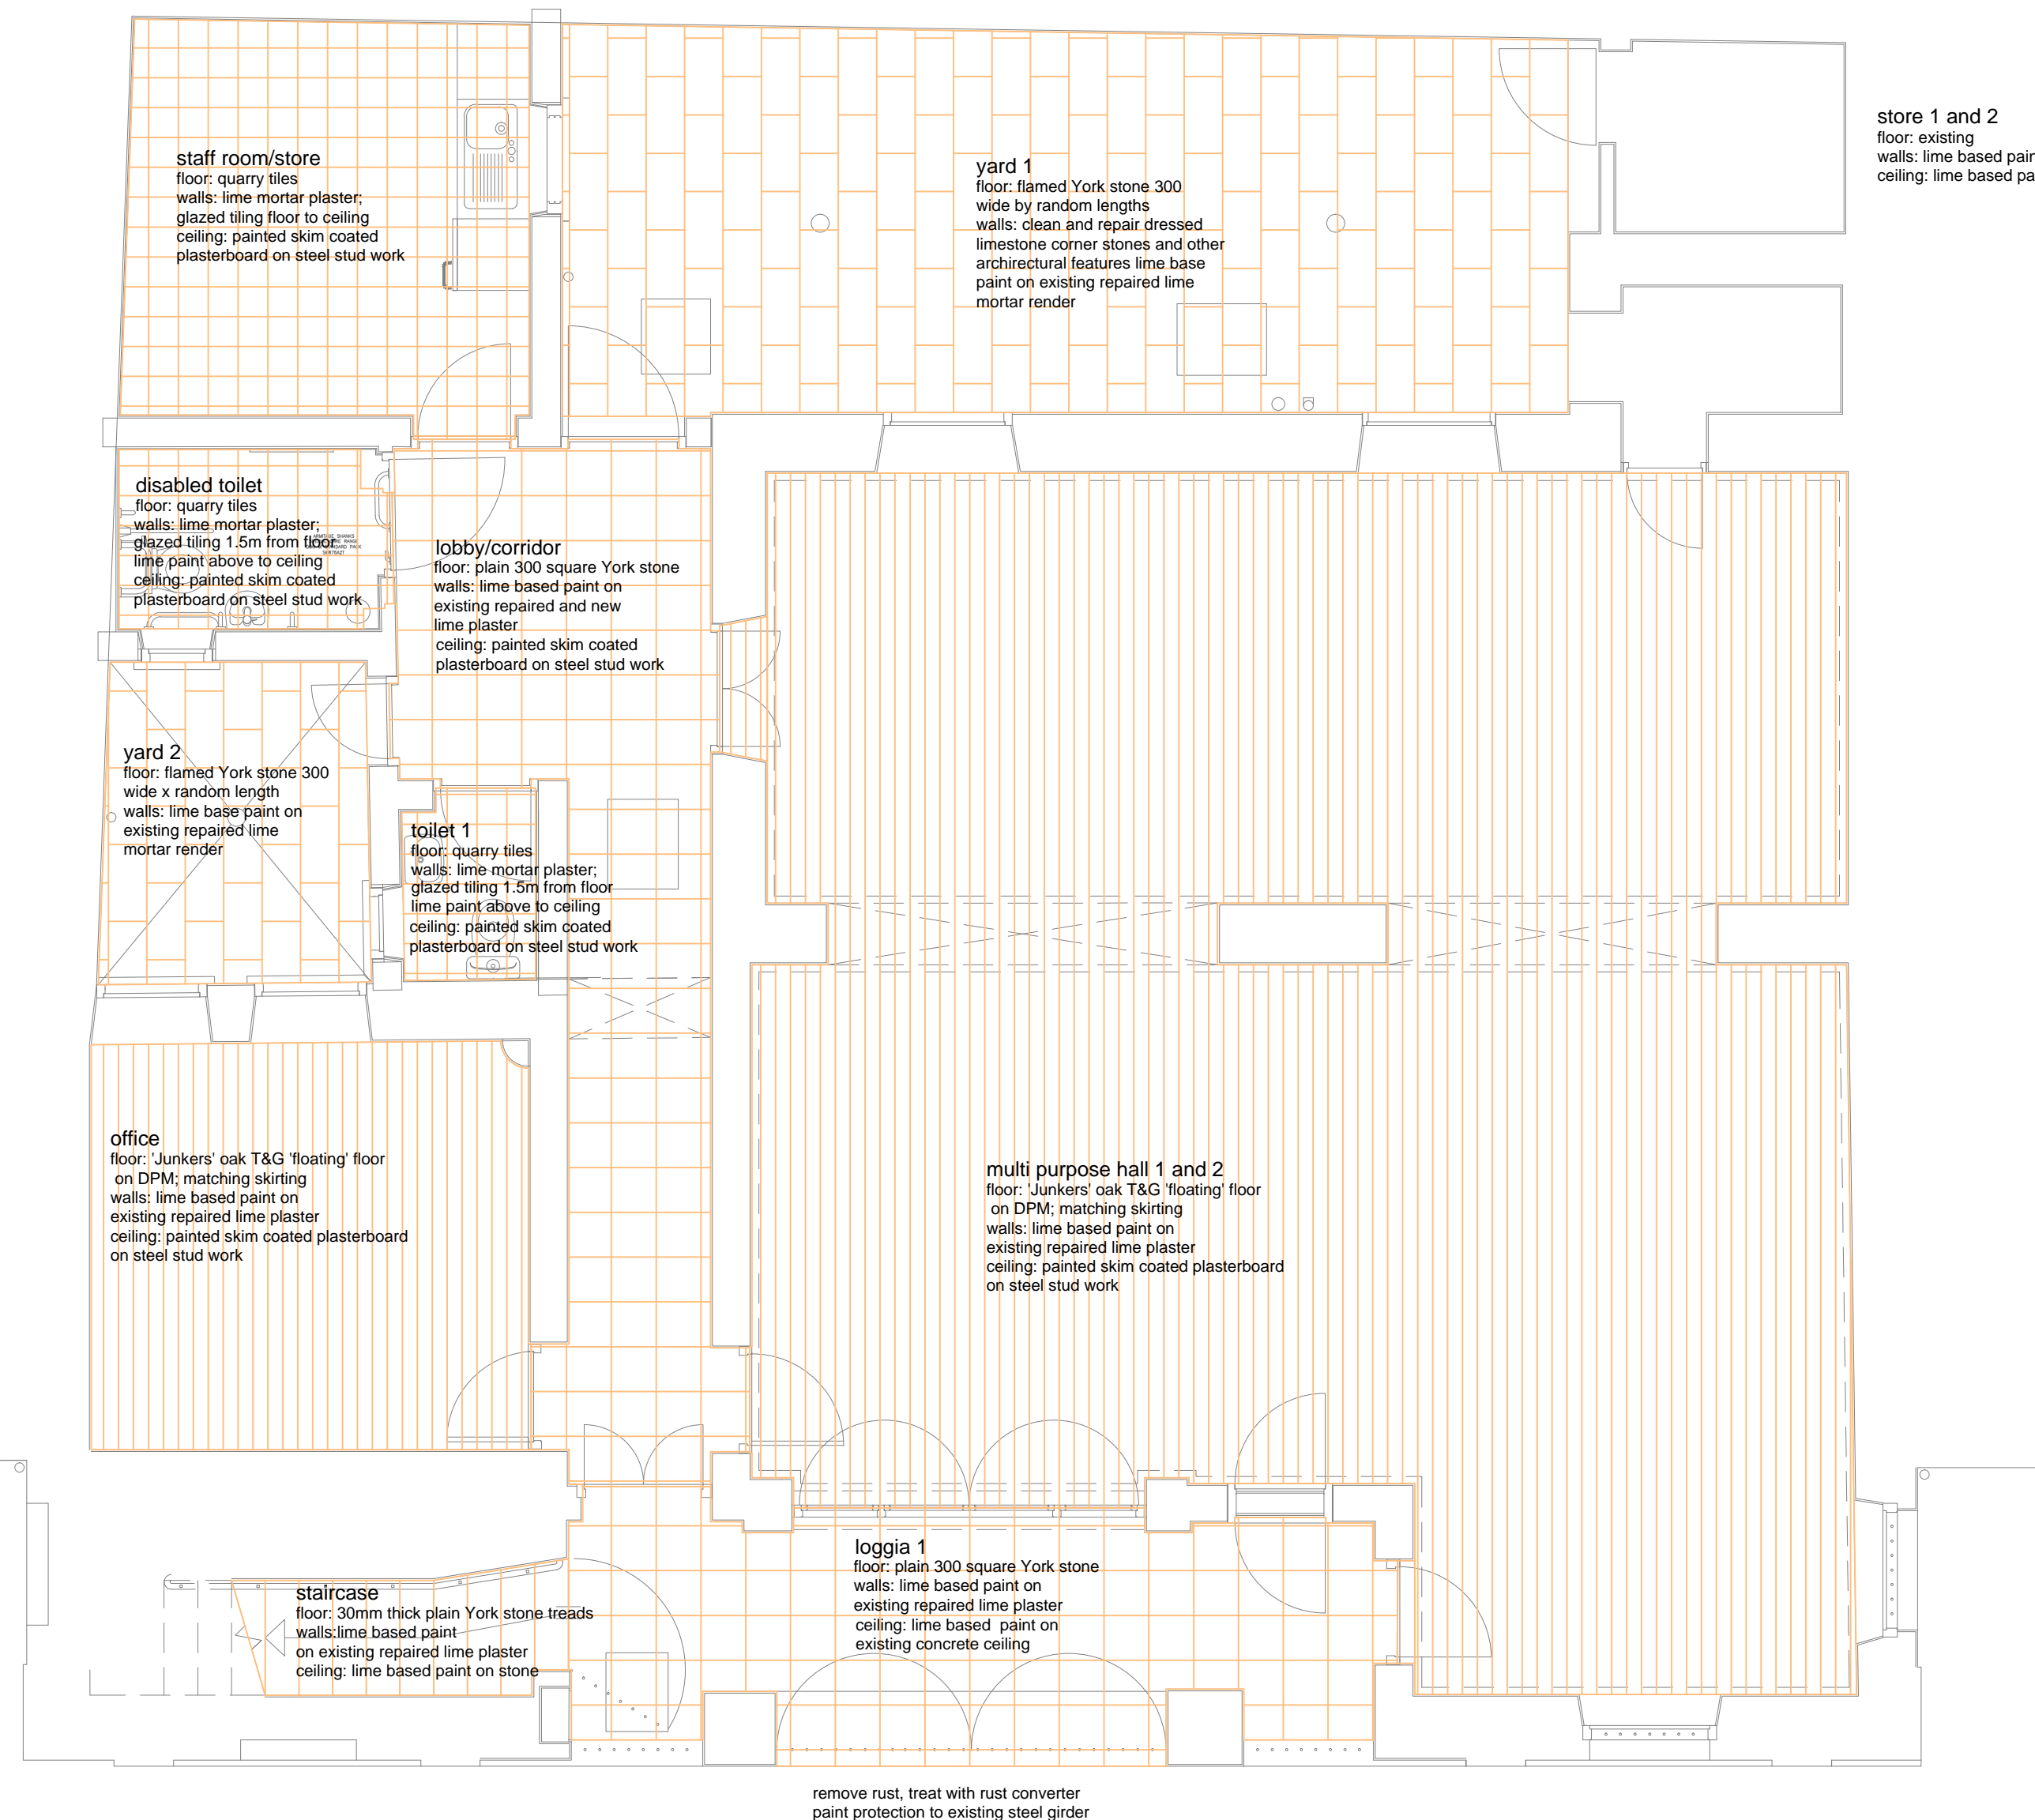
Facade
 Clean and repair dressed limestone pillars, corner stones and other architectural features
 lime base paint on existing repaired lime mortar render

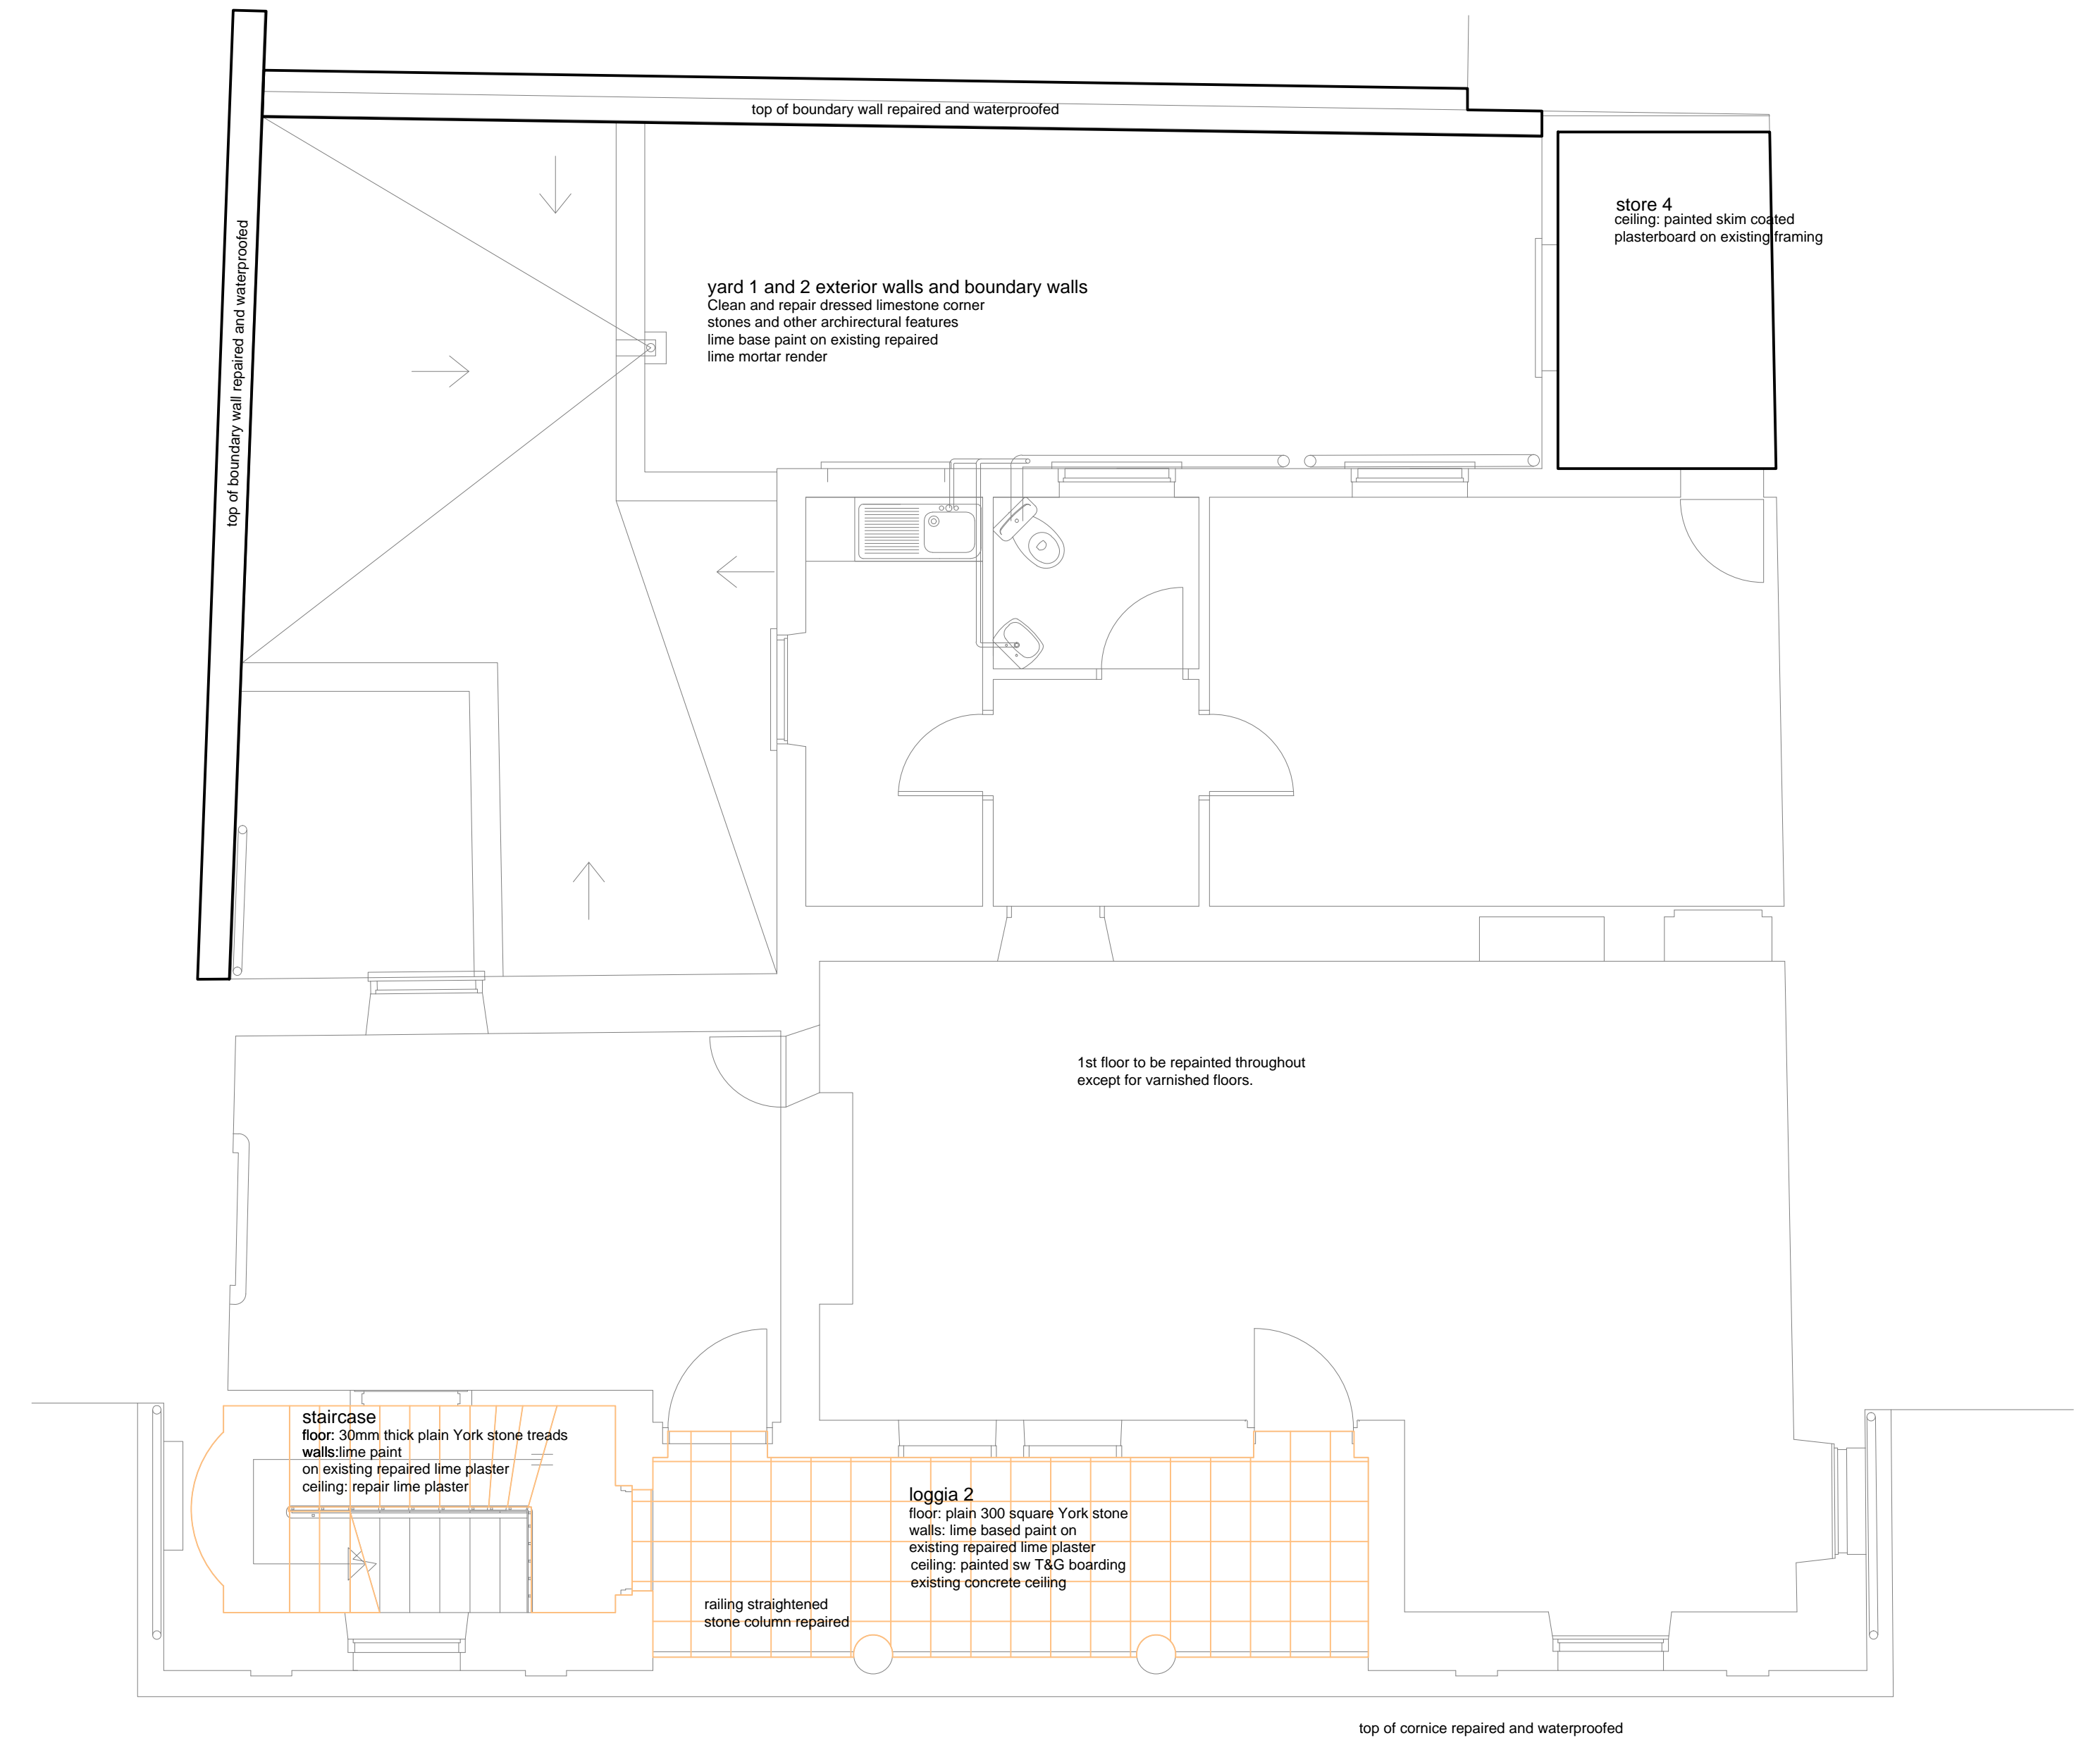
Facade
 Clean and repair dressed limestone pillars, corner stones and other architectural features
 lime base paint on existing repaired lime mortar render
